## EVO: Wheels, Brakes & Tires - Sub-02R

### Known issues with the 2004-2007 Style Rear Master Cylinder

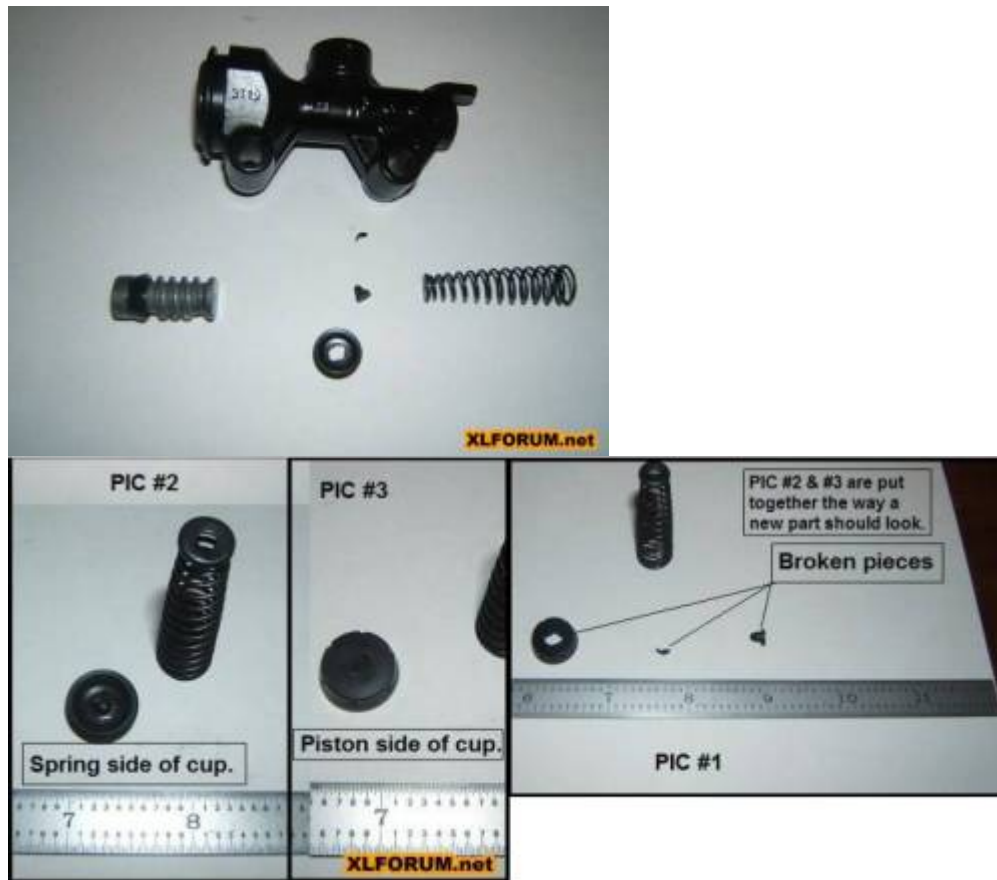
What seems to happen is that the primary cup gets torn in the center and it manages to still work as long as the MC is not disturbed much.

The cup is backed up with the flat metal plunger which helps it seal even though it's broken. Then they are a hard to bleed. But with a broken cup, they won't bleed anyway.

If you take the broken cup and the spring and hold them together on the bench, you will see that the washer can slide sideways quite a bit.

(within the center of the primary cup)

The tapered spring may try to cock some every time the pedal is pressed causing it to work against that tit until it breaks the tit off.

This leaves a split across the cup.

You may could try adding a larger washer on the end of the spring so that it will not keep fighting the tit for centering.

Bleeding is the other problem, and the big loop in the brake line is a possible cause for this (trap for air). Some have also said that the return hole in the MC is too small. But enlarging it is risky unless you can make sure that there is no burr left to hurt the new cup.

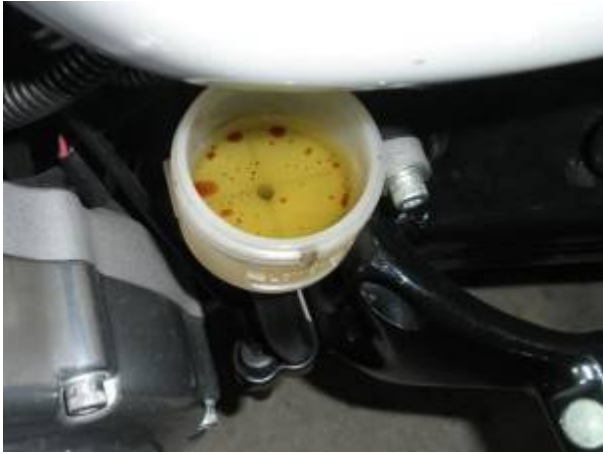
3)

This phenomena is still a mystery but it has been noticed repeatedly in the brake fluid reservoir especially in 2004-2006 Sportsters using DOT 5 fluid.

It has been said to look like a mixture with the appearance of Italian oil and vinegar dressing with an orange tint. <sup>2)</sup>

One idea is that DOT3,4 or 5.1 might have been added to (top off) the fluid level.

But that would cause thick goop to drop out of suspension as the fluid would coagulate into thick gumps.
