This article is an excerpt from Hot XL Magazine, Autumn 1997 Edition: <sup>1)</sup>

# 900 TRANNY FIX

## How To Fix A Cracked Countershaft Bearing Boss

Text and photos by Tom Hurd

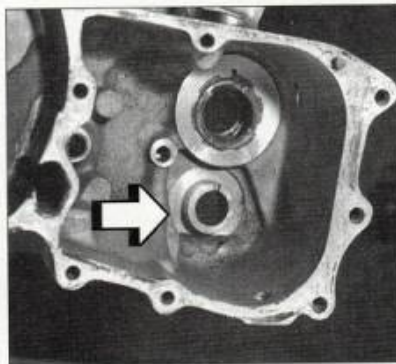
Unless your nickname is "Hole Shot Harry," this section of the case should be fine on a stock horsepower/torque engine. But with a mill that has more power and/or there are a few hole shots in the engine's past, there's a chance this bearing boss is cracked. Once the boss cracks enough, the bearing fails, the countershaft cocks, and in a split second your transmission is garbage and parts of your case are on the street mixed with tranny oil.

This small boss (see arrow) is the weak link in the drive line. All 1973 and later Ironheads have more than twice the wall thickness of this boss.

Thankfully, there is a fix (besides replacing the case). It can be performed as an ounce of prevention or, if it's too late for that, as a solid, permanent repair. This job is going to take some work, but it's a lot easier than replacing the case. To do it, the engine cases must be split and the right case stripped of all components (other than

With case in hand, it's time to go to your trusty machine shop. To reinforce or repair the bearing boss, an aluminum ring has to be made on a lathe. It must fit snugly around the old bearing boss and be about the same diameter as the flat area on the countershaft first gear. The ring should also be thick enough so its outside surface can be planed flat with the surface of the case's boss after the ring is pressed on.

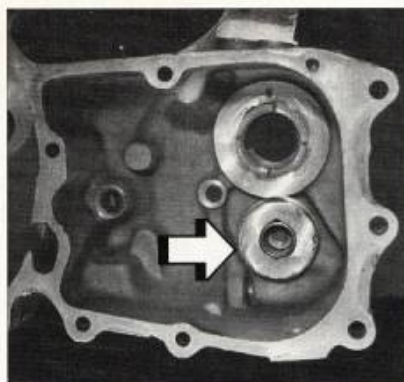
This is the new, improved bearing boss (see arrow). The bearing support area is now much like that of the 1973 and later Ironheads. When pressing in the new bearing, keep it straight to avoid distorting the outside of its housing and be sure to put a little sealer on the outside of the bearing.

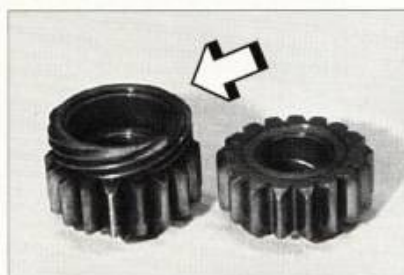
Two types of countershaft first (low) gears were used in Ironheads. The gear on the left is the early style (1957 to 1972 and 1954-and-up KHs). It has a worm gear (see arrow) that drives the speedo cable. After modifying the earlier cases, there's no longer room for the speedo drive gear. The gear on the right is the 1973 and later version (H-D # 35760-73). The old style gear can be modified to work but it's not worth the effort or cost.

The parts you will have to purchase, besides the necessary gaskets, will be a 1973 or later first gear (H-D # 35760-73), a new countershaft (unless it's in good shape with not even a hint of bluing where the shaft goes into the bearings) and the
