# REF: Engine Mechanicals - Sub-01W

## Aftermarket Lifter Issues

### Roller Pin Manuf. Defect and Repair

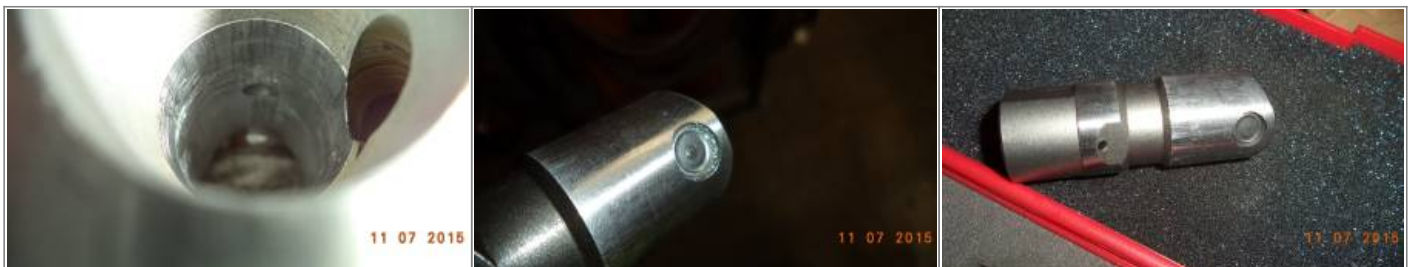
The lifter was cutting into the bore while installing them and turning them sideways.

The extruding sides were cutting on the opposite ends of the roller caps and gathering aluminum shavings in the pin hole recesses.

Upon measuring, the main body on this particular set of Fueling lifters were .903" on the main body with the roller end being .9035".

When the lifter roller pins (or pin caps) were pressed in, this process apparently warped out both opposite sides of the barrel ends.

This is similar to squeezing the top of a paper cup. The factory clearance is .0008"-.0020" and out of service limit at .0030"

The distance from side to side opposite the roller pin sides had a diameter of .0005" more than the main body.

The extruding part of the lifter base acted as a cutter on the lifter bore.

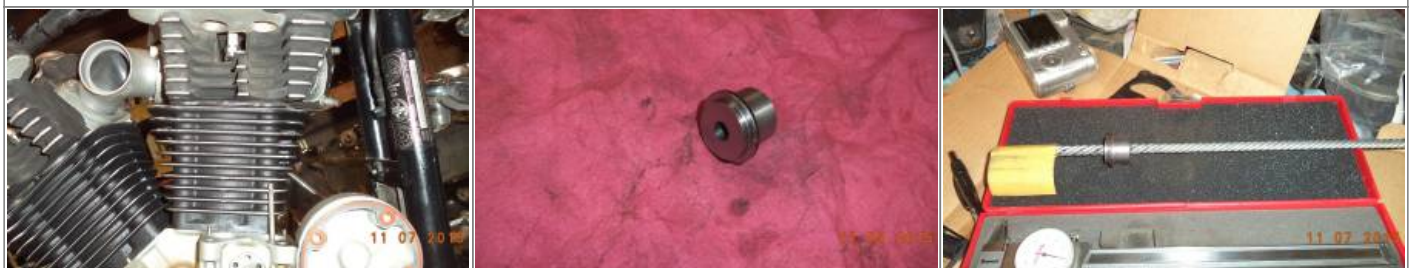
91-Up lifters are not in replaceable lifter blocks. So wear in the bore is critical.

The FSM says since this model has no tappet bushing, the only way to fix 'out of service bores' are bigger tappets or a new case.

Homemade hone to lightly clean up the lifter bore. <sup>3)</sup>

So the bore was honed slightly to remove the bulk of the scratches made by the oversized lifter end.

The hone was made from a ball hone with the balls removed and 400 grit sandpaper Gorilla glued to the shaft.

To keep center on the hone, a bushing was cut on the lathe with a slip fit hole small enough to accept the wire handle.

The bores are slanted toward the pushrod cup of each rocker arm. <sup>2)</sup>

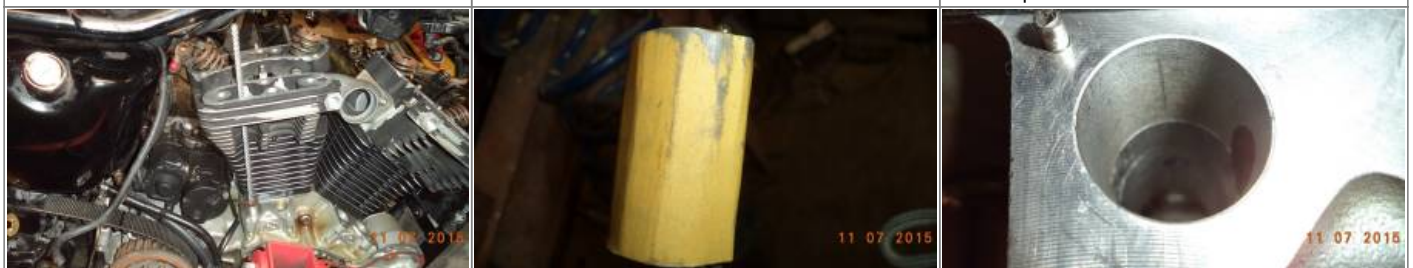
This is all that was removed from all 4 bores combined and from the bottom of the bores. <sup>5)</sup>

All scratches weren't removed but honing too much would open the bore too far. <sup>6)</sup>

The hone was turned by hand for app. 10 turns (while holding the bushing in place) per lifter bore to clean up the scratches.

Due to the slanted bores, the bushing was raised slightly while honing.

Hone held through center of pushrod hole. <sup>4)</sup>
