## REF: General-MSR 07

# Diagnosing Catastrophic Engine Failure in Evo Engines

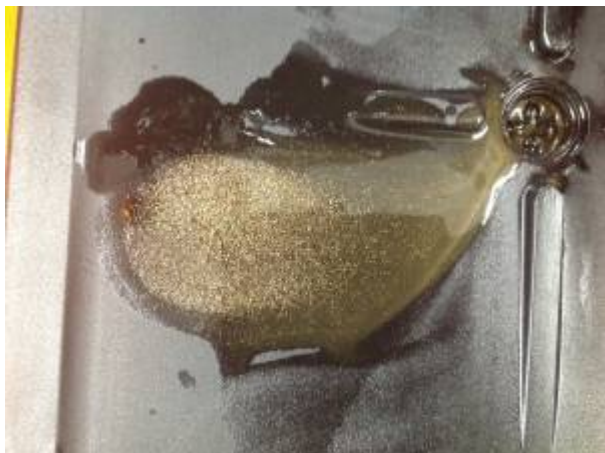
If something like this comes out when you do an oil change, find out if it's metal or brass / bronze and start diagnosing where it came from.

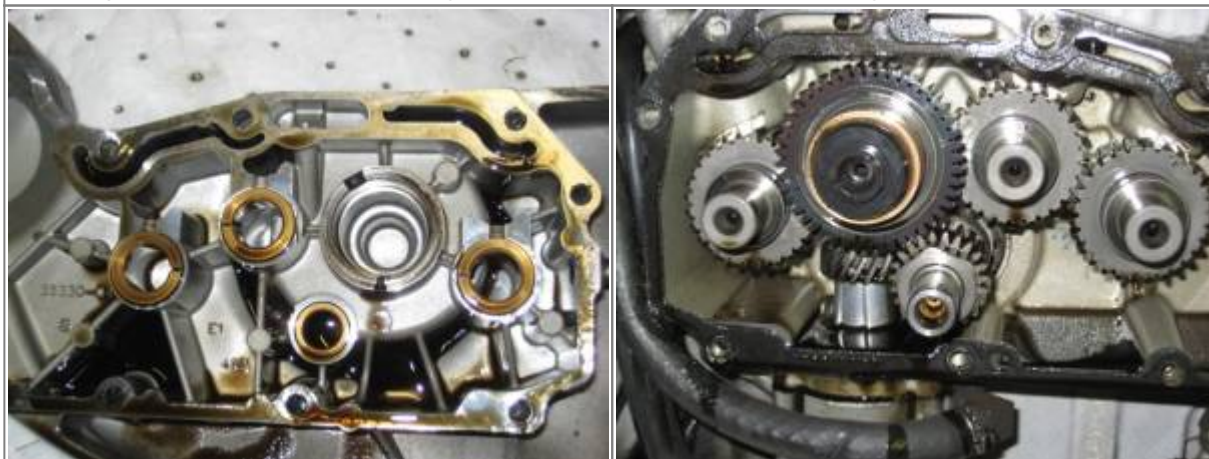
Spun #2 outer cam bushing, 2006 cam cover. Heat coloring on front of cam. <sup>13)</sup>

- **Repair.** When the bushings spin in the cases, they don't leave a perfectly round bore. As they spin, they rip/ream some of the bore I.D. and may move the bore center.

Finding that center with oversize bushings should be done by a qualified machine shop.

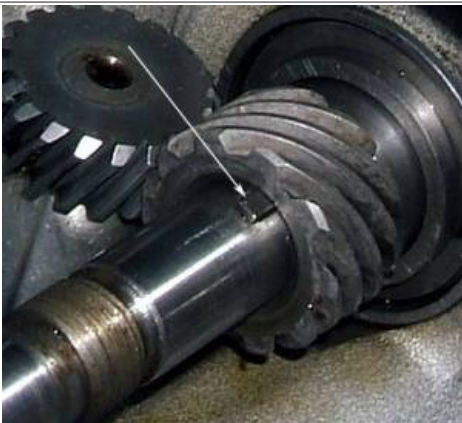
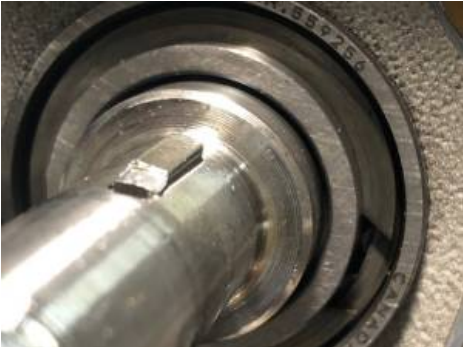
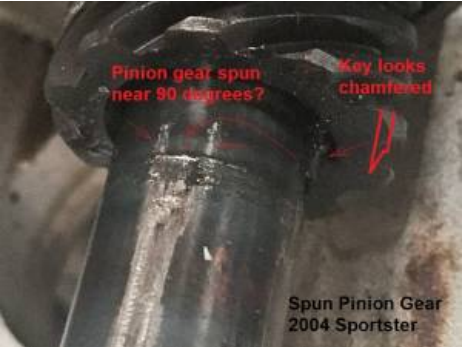
- In the pics below, the little nub of the key that protrudes from under the oil pump gear is the only portion of the key that engages the pinion gear. <sup>16)</sup>

That's why it shears so easily if the nut is loose. There just ain't much holding it besides the clamp force of the nut.

- Breaking the key is a very common issue particularly when heavy valve springs are used. The force from the springs transfers thru the cams to the pinion gear and puts extra pressure on the pinion key.

And that force may be enough to break the key allowing the pinion gear to move.

| Pinion key location <sup>18)</sup> | Condition of key after gear spins <sup>19)</sup> | Pinion gear spun (app 90°), stopped and still turned the cams from new location <sup>20)</sup> |
|---|---|---|
| <p>The pinion gear is located by the little nub of the oil pump drive key that you see sticking out. With high valve spring pressures, this nub often shears off, sending pistons crashing into valves. Avoid this issue by torquing the pinion nut to 70lb-ft. Be sure to use Loctite red on the threads per the manual.</p> | | <p>Pinion gear spun near 90 degrees?</p> <p>Key looks chamfered</p> <p>Spun Pinion Gear 2004 Sportster</p> |

The fix is Loctite red and 70ft-lbs instead of the factory specified 35-45ft-lbs. You won't have this issue again. <sup>17)</sup>

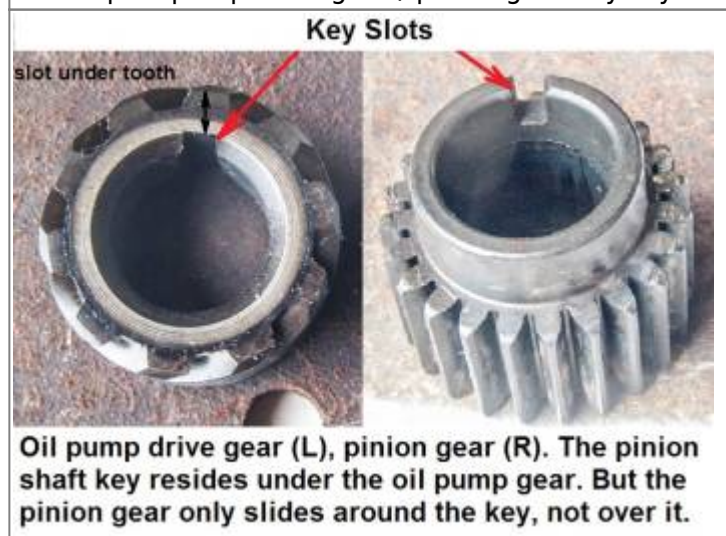
1988-up oil pump drive gear / pinion gear keyways. <sup>21)</sup>

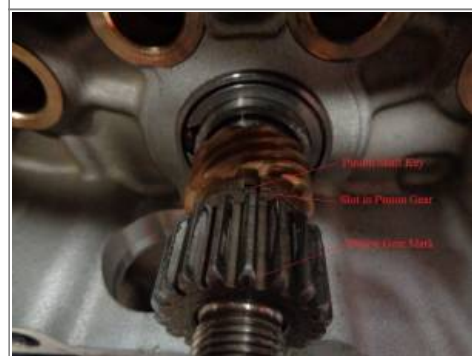
Pinion gear slot aligned with pump gear face. <sup>22)</sup>

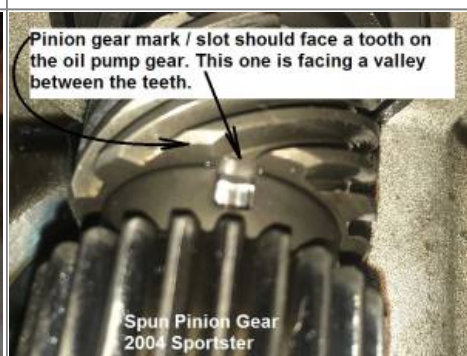
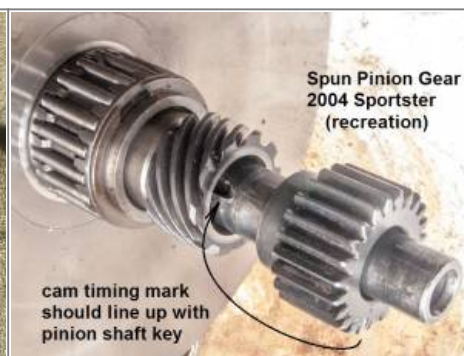
If the pinion gear slot is facing a valley (between two teeth) on the pump gear, the pinion key (at least the part that holds the pinion gear) has sheared.

And the pinion gear has turned to some degree out of time with the crankshaft.

Spun pinion gear. <sup>23)</sup>

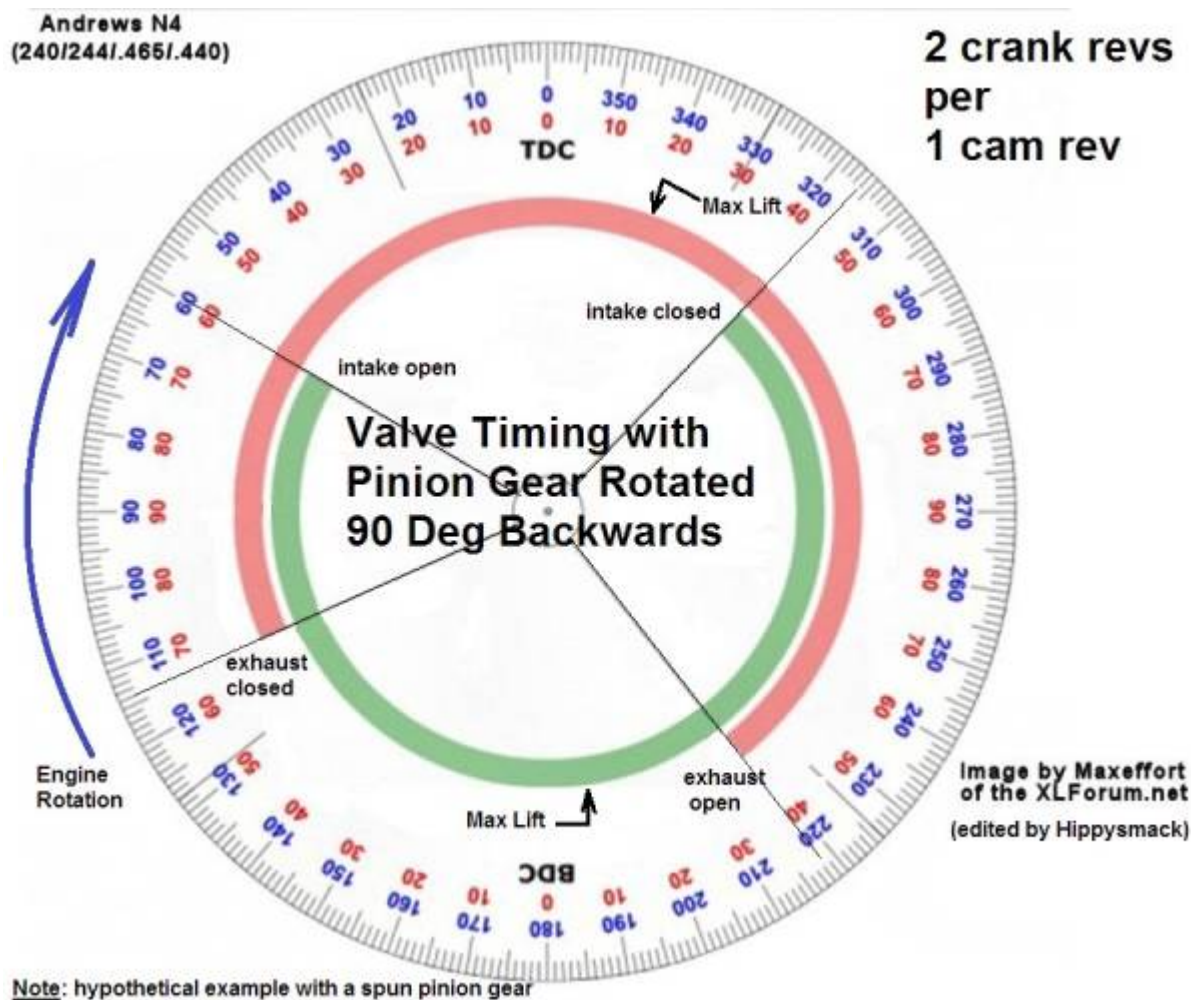
The intake cam lobe center (point of max lift) is now resting at app. 8° after BDC.

On the next TDC event (360° of crank movement), max lift (180° of cam movement) on the intake valve will occur at 8° after TDC.

The exhaust cam lobe center (point of max lift) is resting at app. 20° before TDC.

On the next TDC event (360° of crank movement), max lift (180° of cam movement) on the exhaust valve will be app 20° before BDC.

So in this example, the intake valve should take the first hit before the exhaust valve would due to the proximity to the piston during rotation.
