TT395: CVO Clutch Line Orientation

November 12, 2008

CVO Clutch Line Orientation

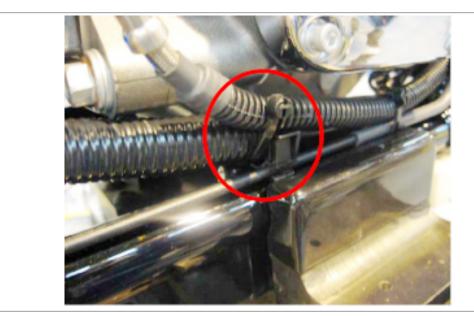
This tie-wrap will be aft of the harness and rear brake line clip on the frame tube. The tie will hold the clutch line to the harness bundle, but NOT to the brake line.

Figure 1. Correct Tie-Wrap Location

The internal fitting change helps the cable maintain its proper location and prevent movement. To maintain orientation and prevent excessive movement at the hydraulic line fitting on models built prior to the change, install a tie-wrap under the transmission trap door to secure the clutch line to the existing harness loom. (see image below)

We recommend installing these tie-wraps on SE Ultra and SE Road Glide models that were built prior to August 31st. Install the tie-wraps on any of these models that are currently unsold in the dealership. Customer-owned vehicles may be updated at any time the vehicle is in the service department for maintenance.
