IH: Body Parts

1973-L1974 Rear Fender Reinforcement Bracket

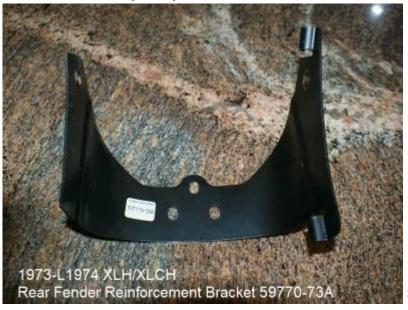
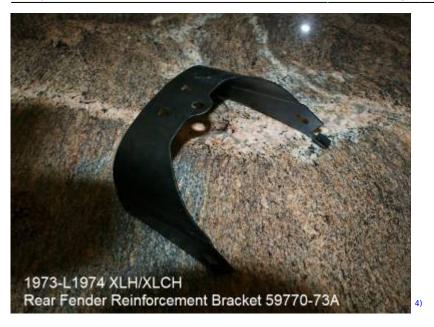
Pics of the bracket (uncut):

- Beginning with late production XL and XLCH models during March of 1974, a spot-welded reinforcement section has been added underneath the fender at the license plate bracket mounting holes. This was done to strengthen that area on the fender where the security system alarm is mounted to protect against cracking of the mounting holes in the fender. 1)

- The bracket (59770-73A) had to be modified at the dealership to fit Sportster models where the bracket (59714-74) for FX and FXE models were a bolt and go. The Sportster bracket was made with tabs on the ends that had to be cut off with a hacksaw to allow for the tail light wiring. ²⁾

- A bolt on version was made available for Early 1974 Sportster models as a replacement on models that had already left the factory before this upgrade was done. It was recommended that the dealer install the bolt on version on all 1973 and 1974 models that were equipped with the security system.
