# IH: Wheels, Brakes & Tires - Sub-01A

## Problems Associated with Drum Brake Rear Hubs

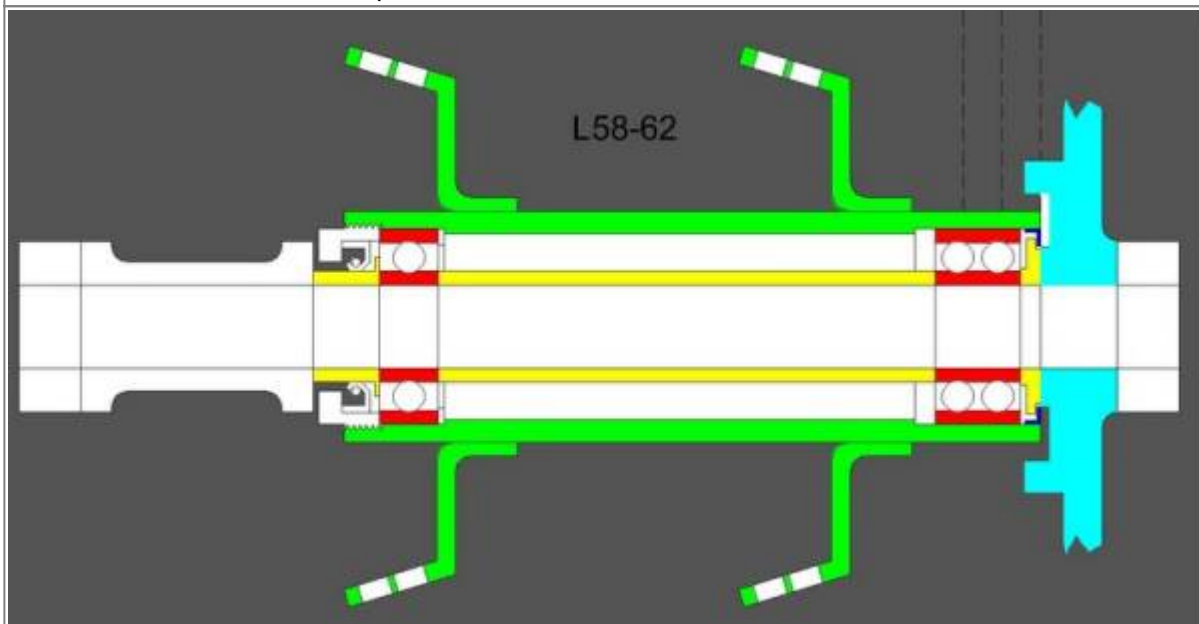
This is the L1958-1962 setup: <sup>2)</sup>

- Now look at the 62< pic at the same area. Much better. Putting the L58-62 bearing, center spacer and shield into a sweat brazed 66-72 hub gives the best bolt together setup.

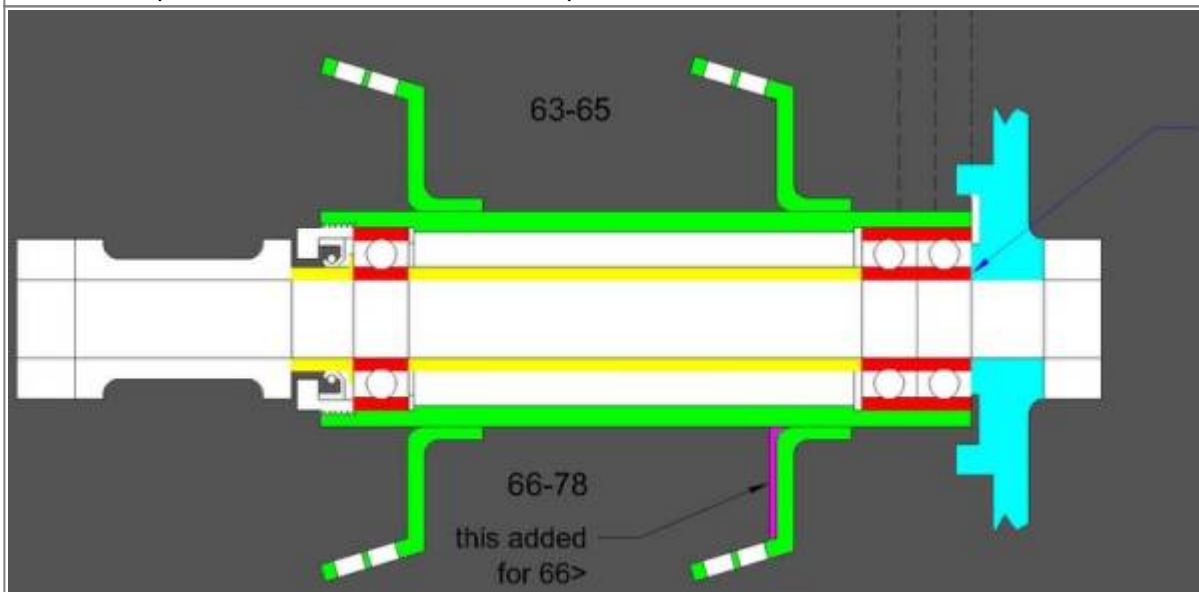
This is two pics in one. The 63-65 is the top half and the 66-78 is the bottom: <sup>3)</sup>

- In the above pics, you see everything that assembles in between the swingarm legs, (i.e. the chain adjusters, backing plate, and axle spool spacer). The dashed lines represent the chain position.
- What you don't see is the tin spool that covers the inner bearing spacer which was left out because it's not part of the structure and it's job is to take up space so you don't have to fill the entire hub up with grease.

- Go back to the 2nd pic. The added meat on the drive side flange was incorporated because the earlier hubs would crack thru the thinner flange near where the flange met the tube. The upgrade stopped the cracking but didn't reduce the forces that cracked the hubs.

- Look at the 2nd pic again where the naked arrow is. That's where the aluminum back plate butts to the bearing inner race. That race will and does plow rite into the soft back plate when the axle flexes. That's not the best scene either.
