This article is an excerpt from Hot XL Magazine, Autumn 1997 Edition: <sup>1)</sup>

## "Zippers Door", Installing One of These May Fix Your Alternator Problem

# ZIPPER'S DOOR

## Installing One Of These May Fix Your Alternator Problem

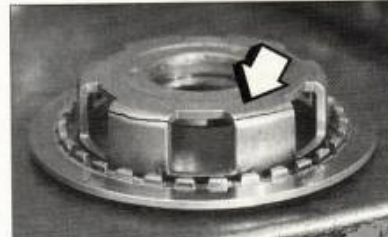
**5** This is what happens if you over-tighten the spring compression tool. No wonder my clutch had been dragging! The last time I installed the clutch myself, I over-tightened the tool which broke the delicate aluminum casting of the pressure plate (see arrow).

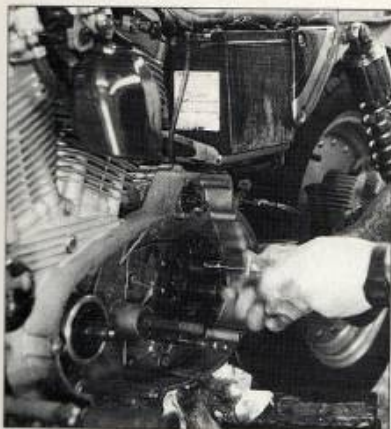
**7** For once, the rotor and stator are still intact. Remove the stator from the old transmission access door.

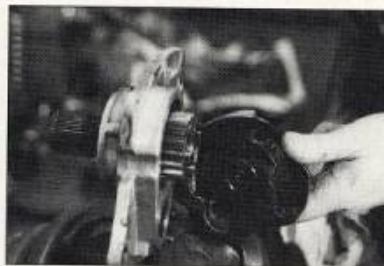
**10** Inspect the shifter cam before removing it from the old door. The thrust surfaces are pretty burred up.

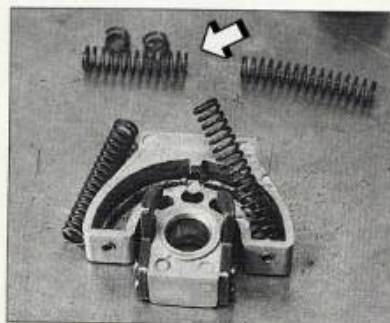
**12** More broken stuff, this time a pawl carrier spring (see arrow). The new ones are sticking out of the shifter pawl. I can't believe this bike was still shifting gears!

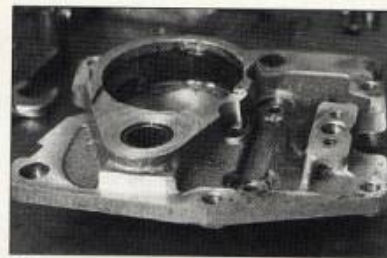
Once the bearings and the cast aluminum trans door get worn, the rotor contacts the stator, and the alternator self-destructs in no time. Either theory may apply, depending on the bike.

**14** This stock H-D transmission door is a cast aluminum unit as are all Sportster OEM doors. However, there is no cast iron sleeve insert for the mainshaft bearing as in the earlier models. This allows the single-row bearing to work in the door and wear away aluminum. Result: the bearing becomes loose in the door.

After installing my third alternator in a year, I spoke to Mike Schute at Apparition Cycle in Michigan. To achieve new-stock-like longevity from my new alternator, Mike suggested replacing the stock mainshaft bearing that's pressed into the transmission's access door. For better-than-stock alternator life, he suggested

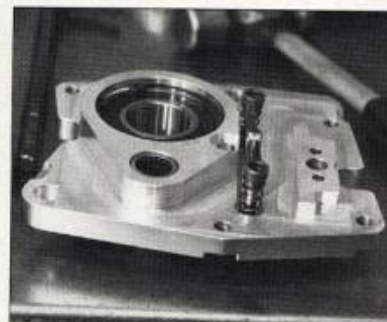
**15** This is Zipper's billet aluminum door. Forged billet aluminum is much more resistant to wear than a cast aluminum one. This, combined with the larger surface area of the Zipper's double row bearing, prevents the wear common to the stock door.

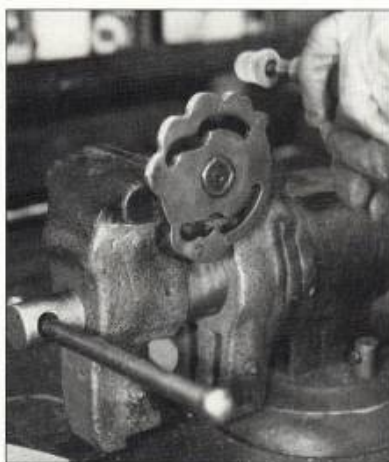
**19** The shifter cam had more burrs than an overgrown cow pasture. Rich carefully cleans the sliding surfaces of the shifter cam where it engages the shifter cam follower so the Sportster will have smoother shifts.

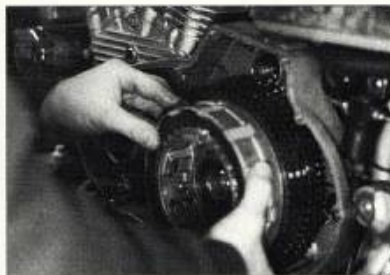
**26** It's time to install the primary drive. Rich gives the clutch shell a hearty shake and states that the whole assembly is much tighter on the shaft than it was with the stock access door.

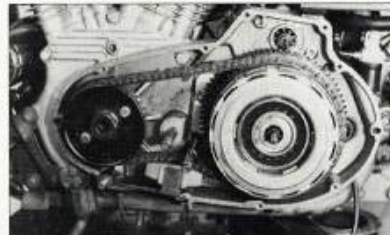
**27** Here's the Sportster's refurbished primary drive, complete with new clutch pressure plate. The clutch shell is noticeably more solid on the mainshaft than with the stock door and bearing.
