# T P S

- August 1993 -#35

# TECH TIPS #35 AUGUST 1993

## 1994 Model Year Technical Update

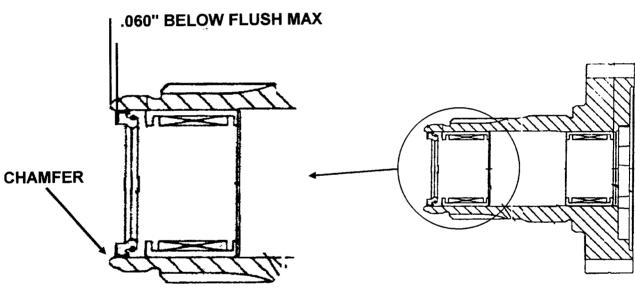
Figure 1

Investigation of the 1340's main drive gear seal, part number 12035, popping out have lead to a better understanding of this situation. There are several conditions that could lead to this or allow it to reoccur on a given vehicle. Here are some of the conditions we've discovered and some recomendations on how to deal with them-

• The chamfer cut into the mouth of some main drive gear's may be wider and/or deeper than on others (see figure 1). The wider chamfers allow for less contact area between the O.D. of the seal and the I.D of the gear after installation. In such cases,

use a thin film of Loctite 601 (green) around the O.D. of the seal and install it to it's maximum allowable depth of .060" below flush.

- A drive belt that is overtight does apply more stress to the seal as well as the bearings and sprockets. Make sure you use the correct belt adjustment technique and specification for the model you are servicing.
- A properly torqued sprocket nut will tend to increase the interference fit between the seal and the gear thereby retaining the seal better. Always use the torquing method described in the previous article for best results.

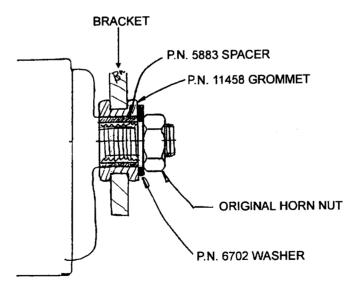
## DYNA HORN MOUNT UPDATE

A 1994 running change to the Dyna's horn mount has improved the horn's performance. This change can be applied to earlier Dynas with poor horn tone by using existing parts and a 9/16" drill. Refer to the accompanying diagrams.

- 1. REMOVE BATTERY BOX FROM VEHICLE
- 2. DRILL OUT HOLE TO 9/16 " DIAMETER
- 3. INSTALL P.N. 11458 GROMMET INTO HOLE
- 4. INSERT P.N. 5883 SPACER INTO GROMMET
- 5. REINSTALL HORN AND COVER USING P.N. 6702

FLAT WASHER AND ORIGINAL NUT

Once the horn is remounted, make absolutely sure that nothing contacts the cover (e.g. battery cable or battery vent hose) or the tone will be disappointing.
