## REF: Service Procedures 11

# 1991-2003 5 Speed Transmission Removal / Inspection / Installation

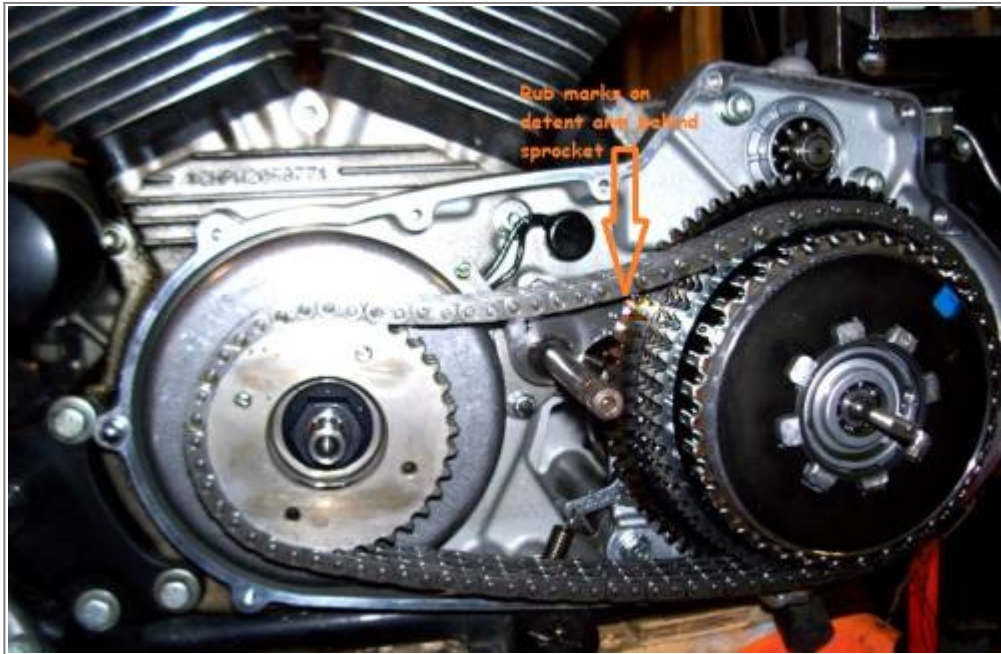
| 1998 1200S Primary <sup>1)</sup> |

The shifter arm will most likely have some light scoring from contact with the back of the clutch basket.

And the starter ring gear teeth have a red tint and scorings.

The detent arm below shows signs on scoring and they are deep across the arm in one place.

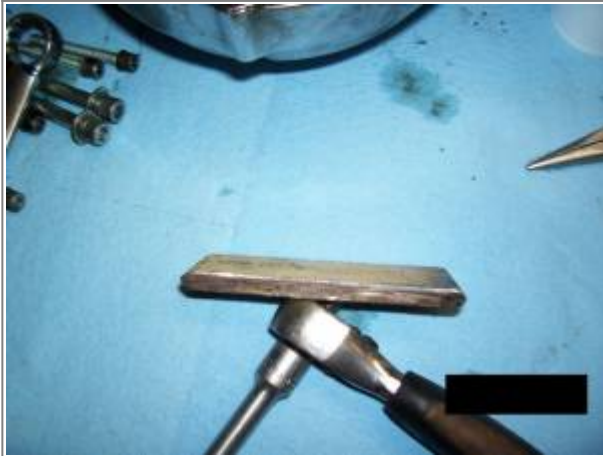
2)

This tool made from 5/16" scrap steel to lock the sprockets (app 4-1/4" x 1-1/2" with beveled the edges).

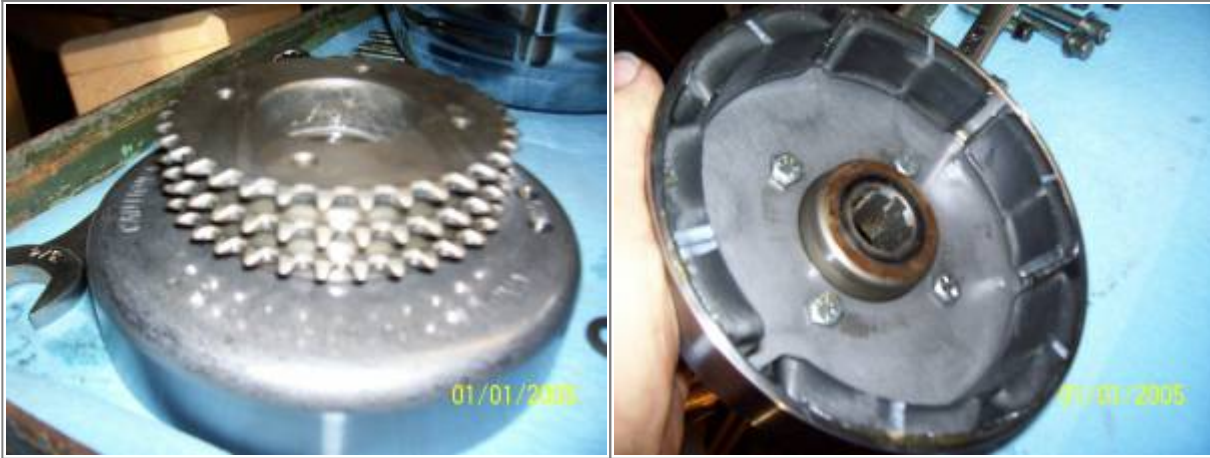
This is why you should not beat on the engine sprocket to loosen it.  
Too easy to break the magnets behind it. <sup>15)</sup>

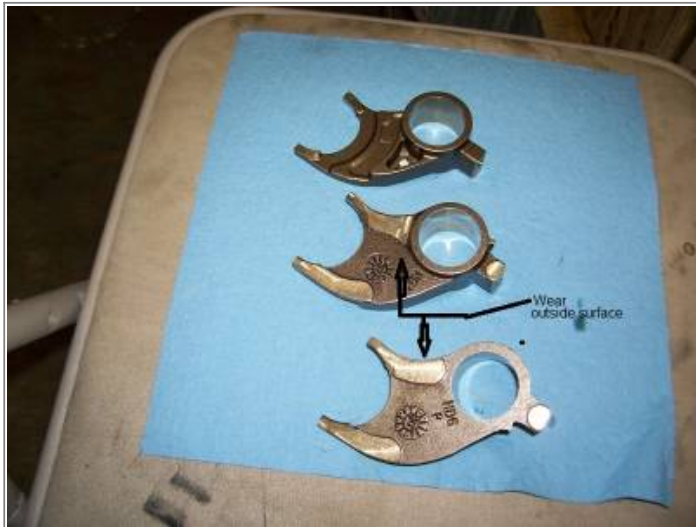
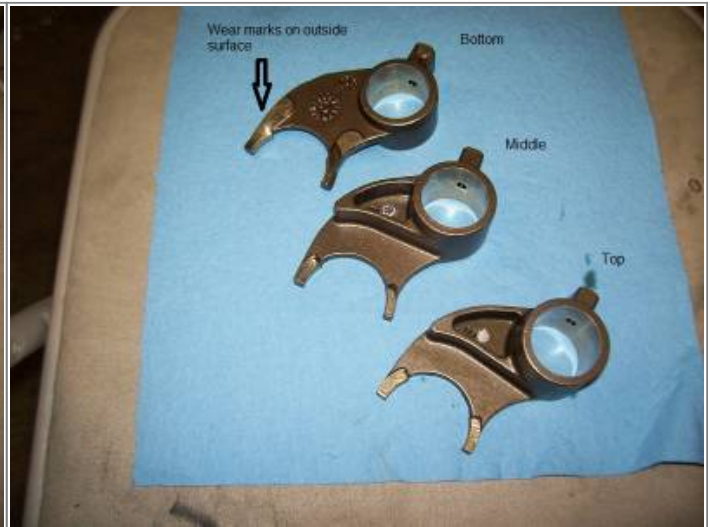
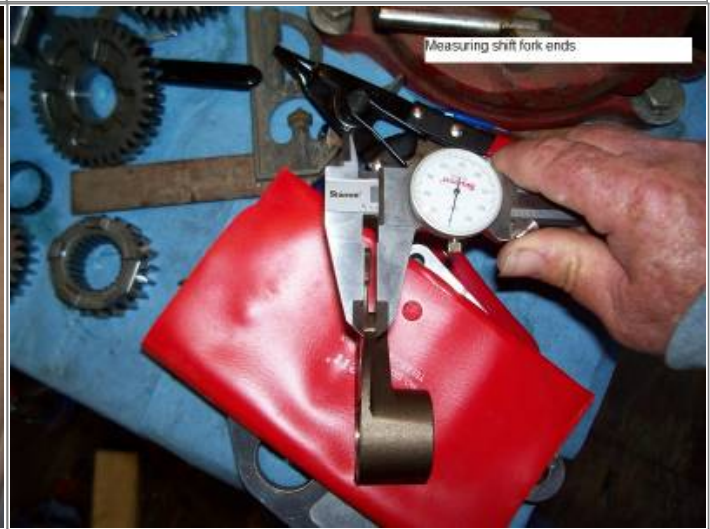
The ones below all have a small amount of wear with the middle one having a wave of wear on the inside surface where it should contact the gears.

Worn contact area equals more space between it and the gears than intended which adds to slop.

The used fork ends below were .202" on both inside and outside edges.

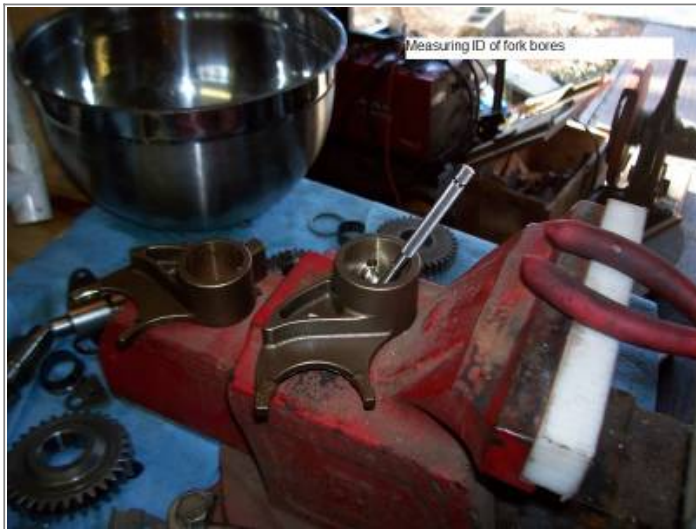
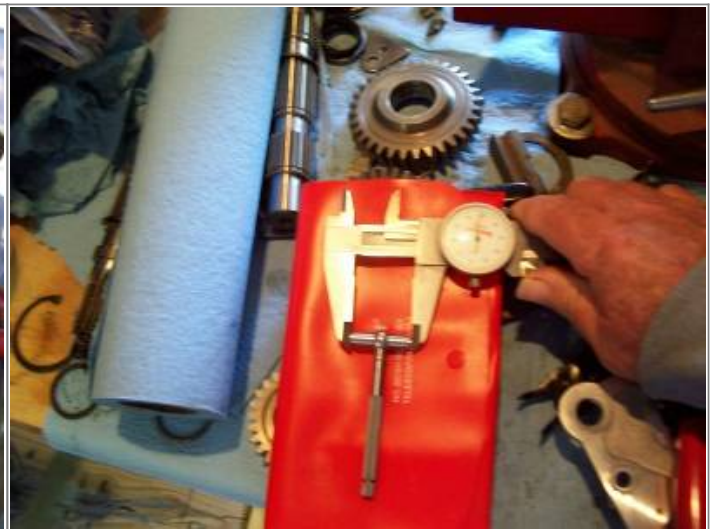
Check the fork ID's to make sure they are all the same. The ones below are all 1.248".  
Excess clearance in the fork to shift drum bore contributes to binding of fork movement.

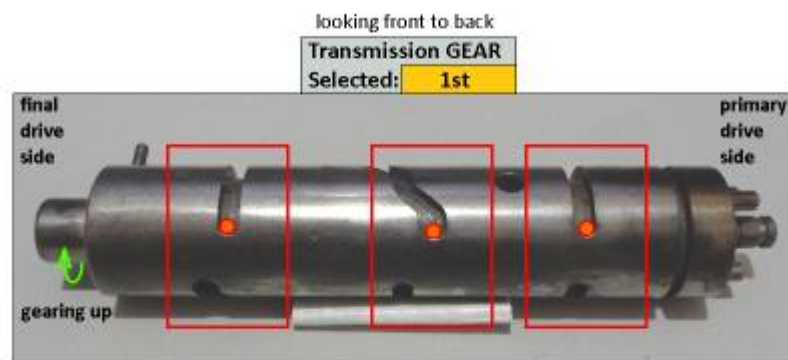
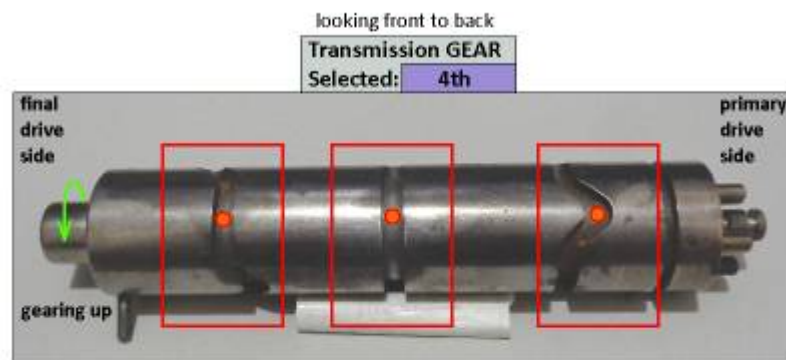
### 1991-2003 Sportster Shift Drum Showing Fork Pin Positions Per GEAR

Below are pics of the shift drum with the fork and fork pin positions for each gear.

You can see at what point along the channel in the shift drum that the forks and their corresponding pins rest per gear select.

The pins ride in channels along the shift drum as it is rotated by the foot shifter. The red dots show app. where each pin (and it's corresponding shift fork) rest in each GEAR.

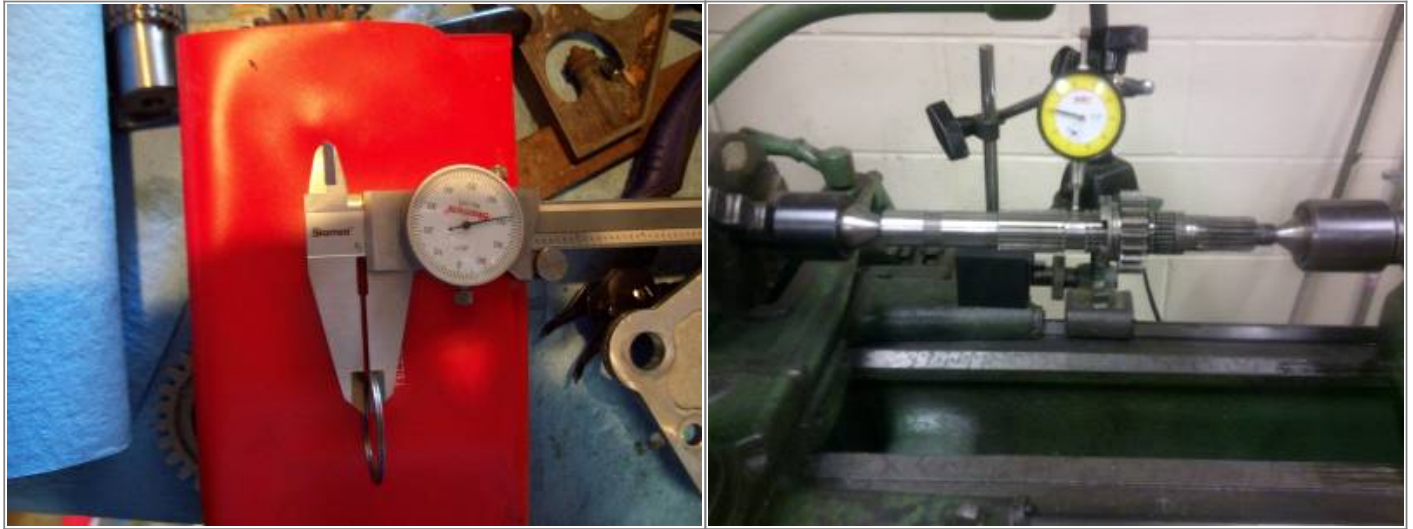
The thrust washers used on the shafts most likely won't all be the same thickness (even when new due to quality control).

The used ones below varied from .0675" to .068". New ones are generally around .069".

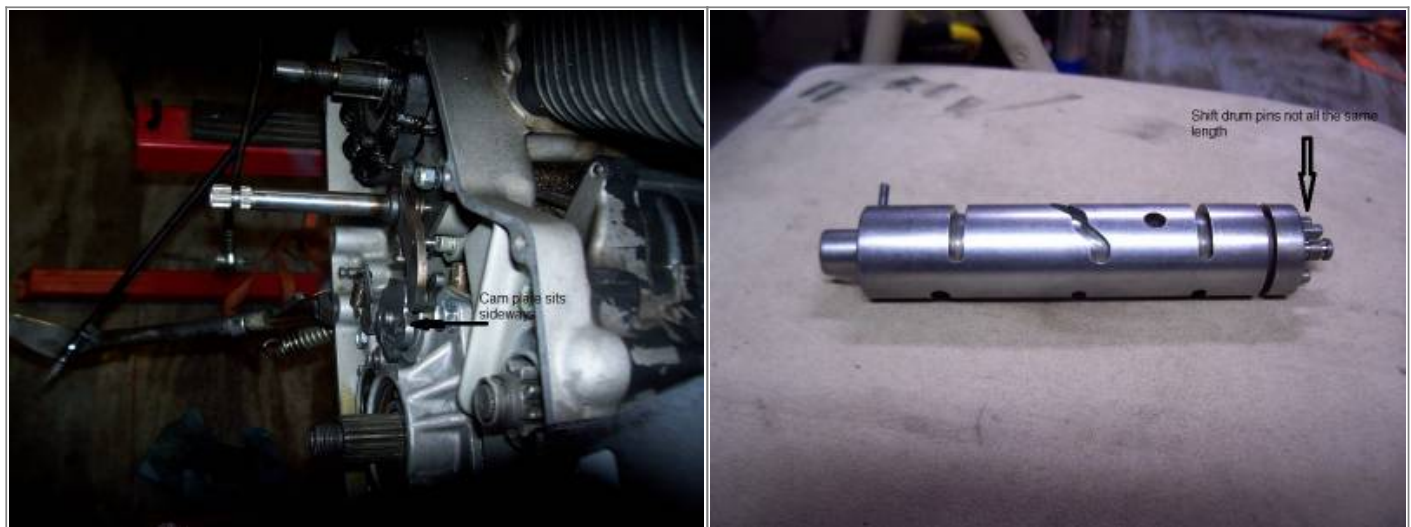
Measure the shift drum pins. They should all be the same length from the drum face (installed height .326" - .334").

However, it is common for some or all of them to pull out of the drum a little.

Some (most) just knock the pins back in the drum with a hammer. And some pull add Loctite to the side of the pins before knocking them back in.

If you pull a pin out to add Loctite, it'd be best to use it on the sides of the pin (not bottom or not in the drum holes).

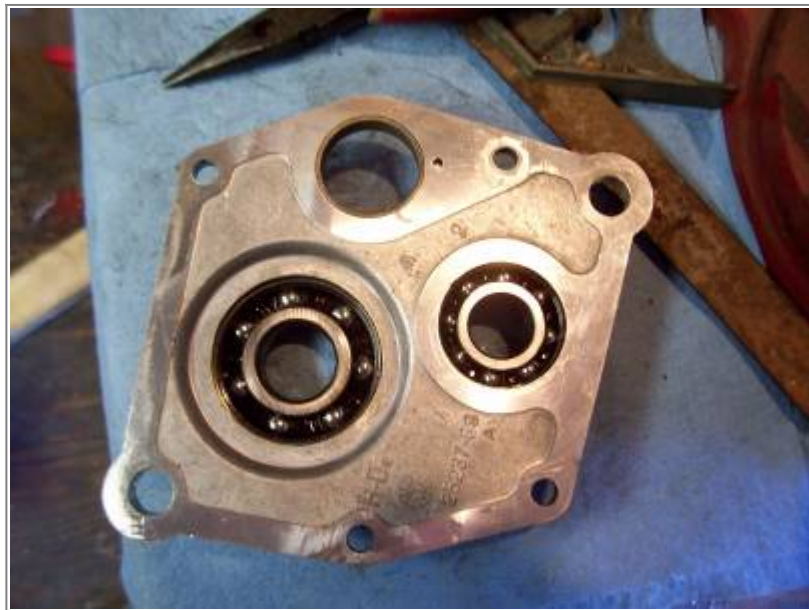
Check the trap door with a straightedge to insure there is no warp-age.

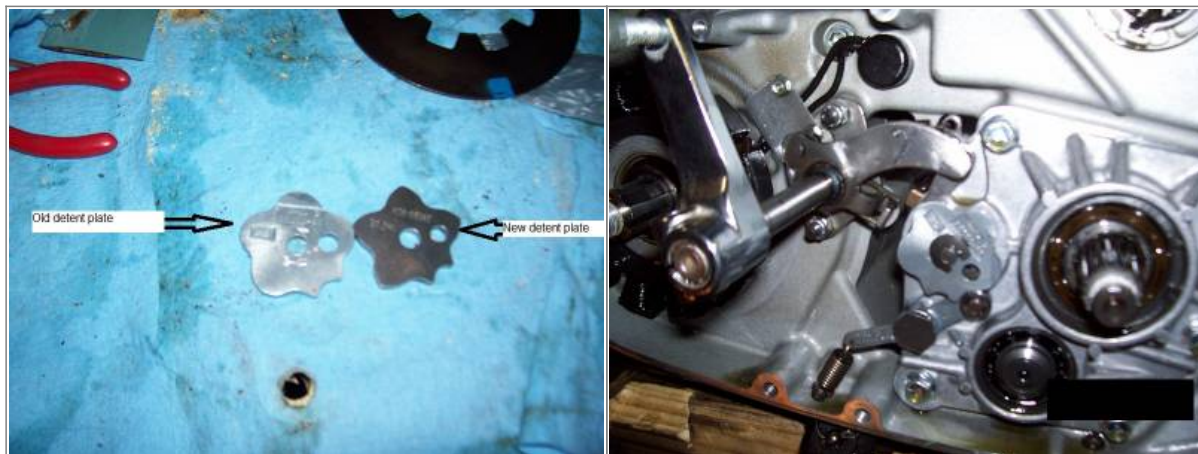
You may find the shifter detent plate to be leaning at an angle with scoring on the outside face. This is a common condition due to the drum pins walking out of the drum at different times and lengths. The detent plate below was found to be leaning and none of the pins were the same length out of the drum.

Also check the depth of the holes the back of the plate that go onto the shift drum pins. They should all be the same depth.

When the pins are forced out of the drum by the shift pawl, the pressure can make the holes too deep making proper re-alignment impossible.

If you haven't already, buy the updated shifter detent plate (33656-90A).

The original detent plate (33656-90 ) which is now obsolete, is made of an aluminum alloy and has longer (slower) drop points for the detent arm.

The -90A is a smaller diameter plate with more radical shift curves and a more positive 'lock in' with sharper drops than the old one.

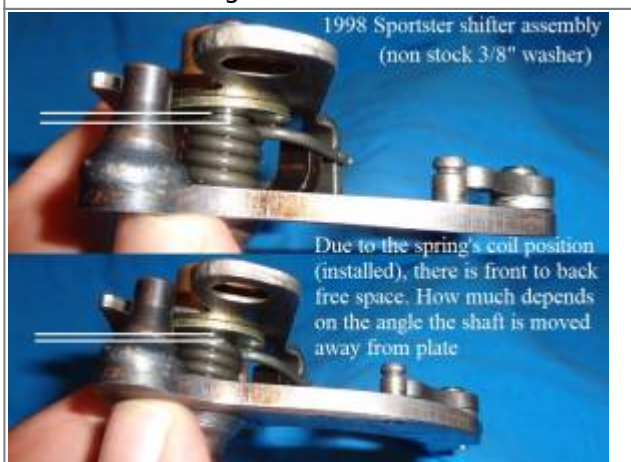
This clearance around the spring coil gives the shift arm's willingness to lean. <sup>17)</sup>

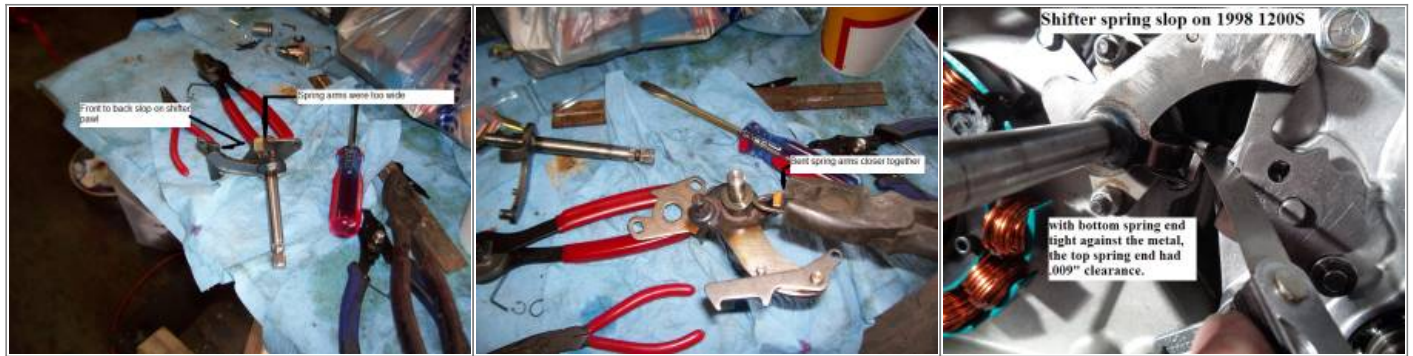
The spring below was adjusted to "0" clearance.

However, after a couple thousand miles, the spring arms did spread out a little (app .009") yet doesn't seem to pose an issue.

You can use some pliers to squeeze those fingers together (closer to their grab points on the shifter assembly).

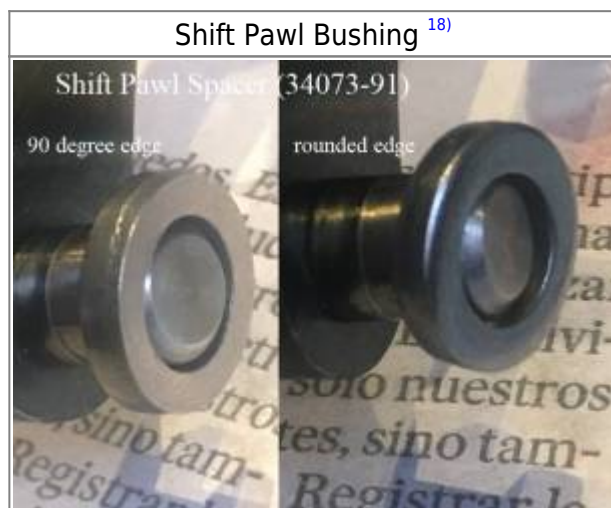
There is a bushing behind the shift pawl and one side of it has a flush cut end with the other side having a rounded end.

This is by design to allow the pawl to have side movement to line up with the pins by gravity before grabbing them.

So there is a bit of slop there but that is normal.

However, that bushing will wear down and a new one should leave a little less slop there.

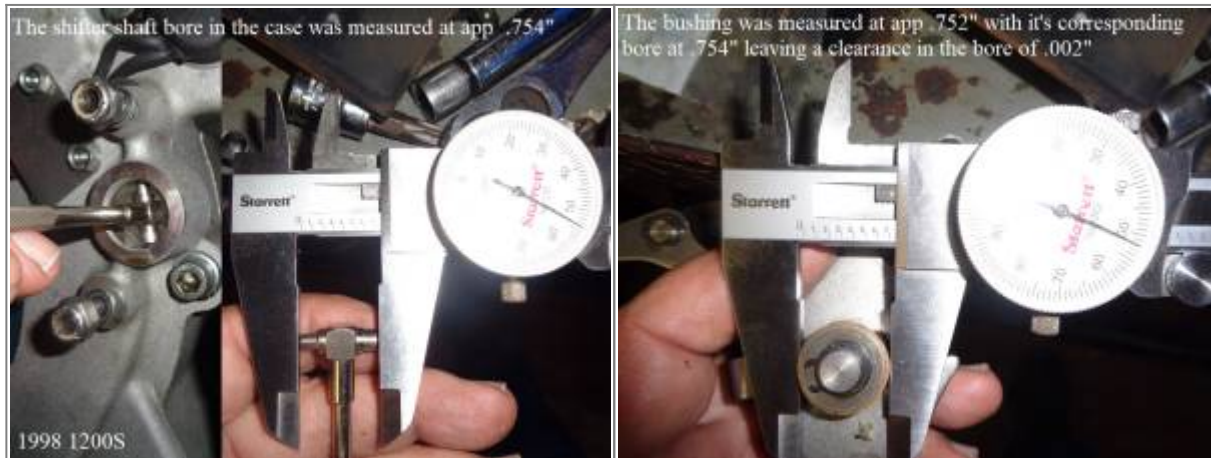
The inner shaft bushing is not a press fit into it's primary case bore but a loose fit and will be easy to slide in and out of the bore.

Inner shaft bushing clearance. <sup>19)</sup>

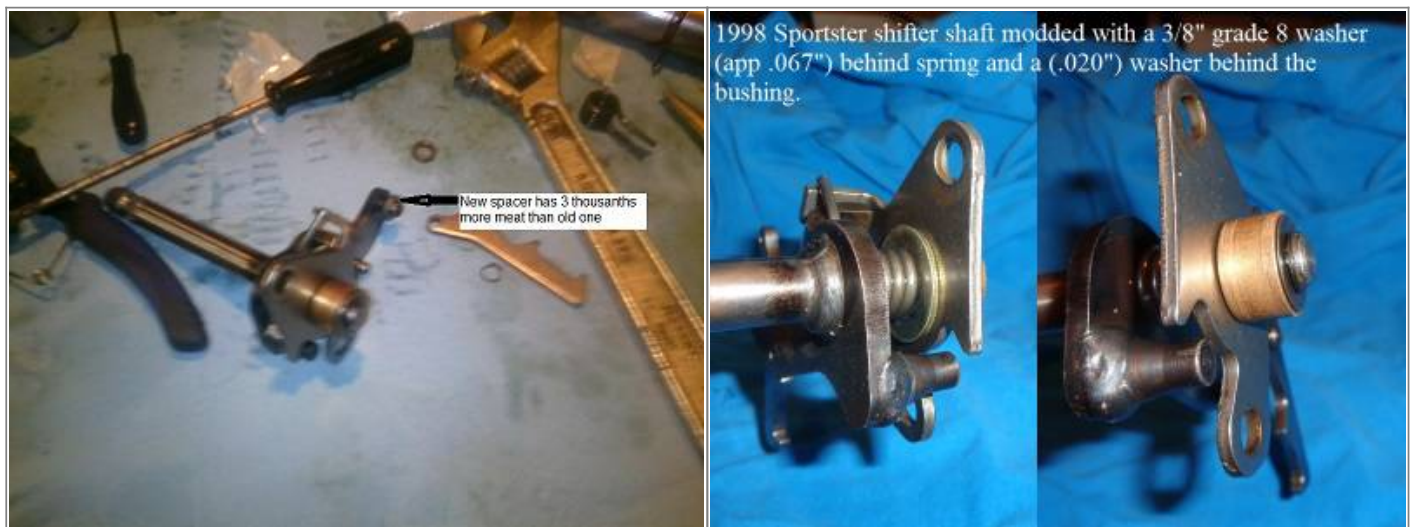
There is a clearance between the inner shaft bushing and the mounting plate due to the coil on the shaft spring.

Worn spacers can add to that clearance. The amount of free clearance there contributes to excess shaft axial movement and shaft slop.

You can use a thicker washer between the plate and spring to beef up that connection and leave a little less slop there.

The shaft will "flex" back a little better with a thicker washer and a thin one on the end.

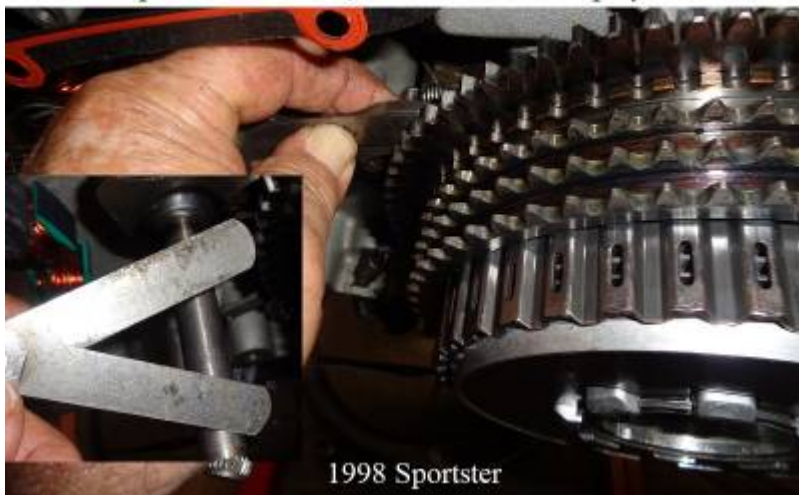
21)

Measuring overall clearance between shift arm and starter gear.  
.043" feeler gauge was inserted with no scrubbing while spinning the clutch sprocket in neutral, shifter shaft lifted up by hand.
