TT397: Original Equipment & Custom Painted Parts Repair

Chassis

December 17, 2008

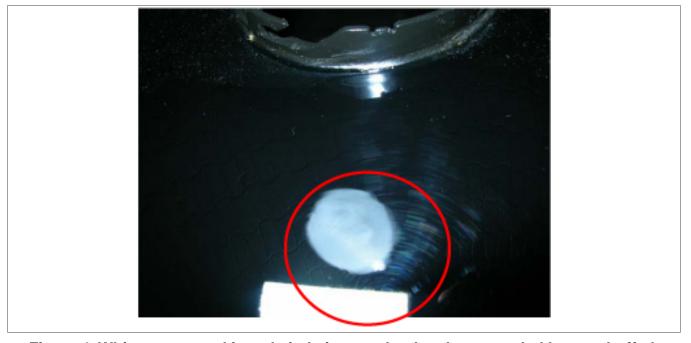
Figure 1. White area noted in red circle is area that has been sanded but not buffed.

This also applies to unfinished repairs. You must perform the **entire** buffing process to try to correct a defect in order to receive credit for your warranty claim. Only performing the first step of repair (sanding) will cause your part to be sent back to you and your claim rejected.

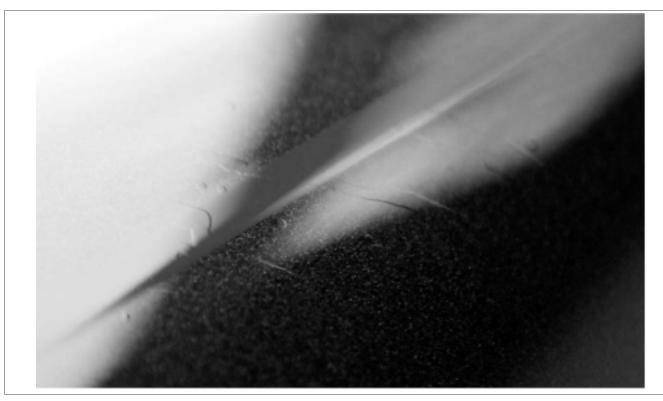
When painted parts are exposed to DOT 4 brake fluid, staining can occur. This condition can usually be repaired using the paint repair process.

Figure 2. Brake Fluid Exposure

If brake fluid is spilled on a part, immediately flush the spill with water, wash the area with soapy water, rinse thoroughly, and dry. Do not use a pressure washer or spray bottle on the spill.

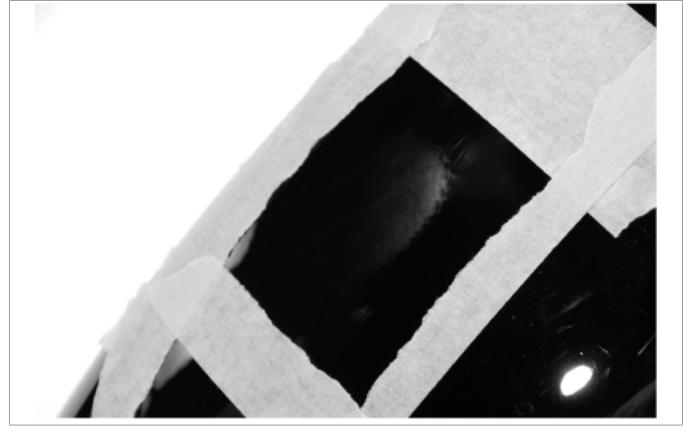
If a hazy condition is present and looks like the picture below, this area was not buffed completely. This can be repaired.

Figure 3. Incomplete Buff
