## REF: General-MSR 07

# Diagnosing Catastrophic Engine Failure in Evo Engines

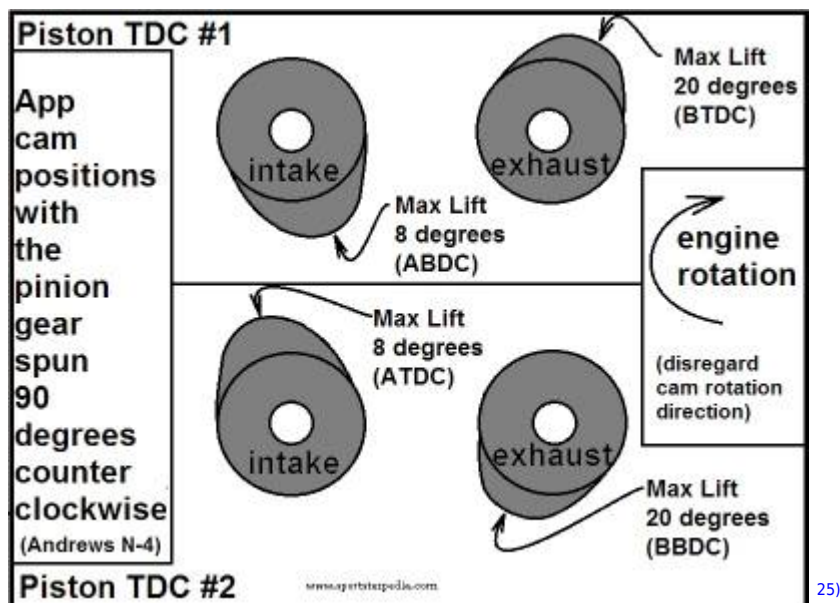
Disregard cam rotation direction as the drawing is showing cam lift / valve opening.

This is simply to show which direction the cam lobes face in the spun pinion gear scenario.
