## IH: Body Parts - Sub-01G

### 1973-1976 XLH, XLCH Sportster Frame Pics

## 1973 XL, XLCH Frame Reinforcement / Tail Lamp Mod

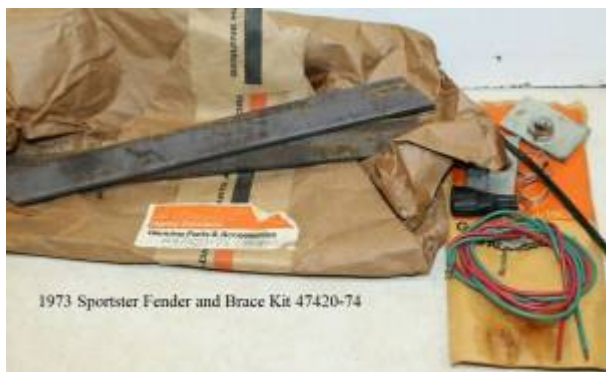
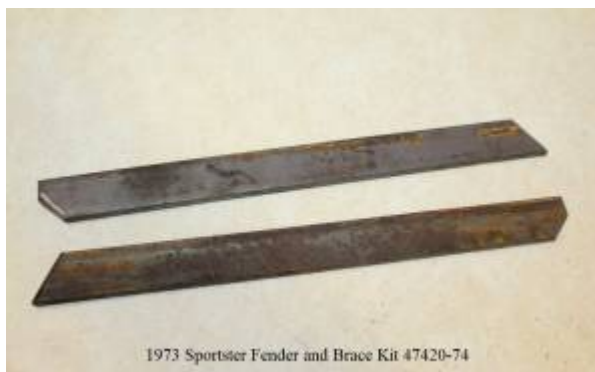
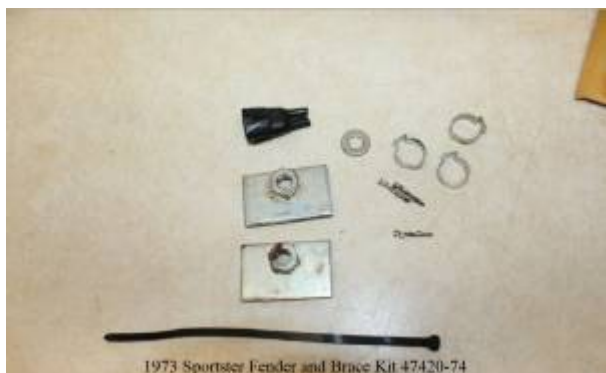
Corrective modification was required to prevent possible breakage at the welded junction of the frame tubes and the rear fender and shock absorber support bracket.

The rear fender support attaching bolts were to be relocated to raise the fender rear end and provide more clearance between the tire and taillight wires.

A Frame Brace and Fender Support Kit (47420-74) was issued to make these changes. Below are contents of the kit.
