## IH: Engine Control - Sub-01C

### Prestolite Electronic Ignition System

## Nosecone Ignition Seal

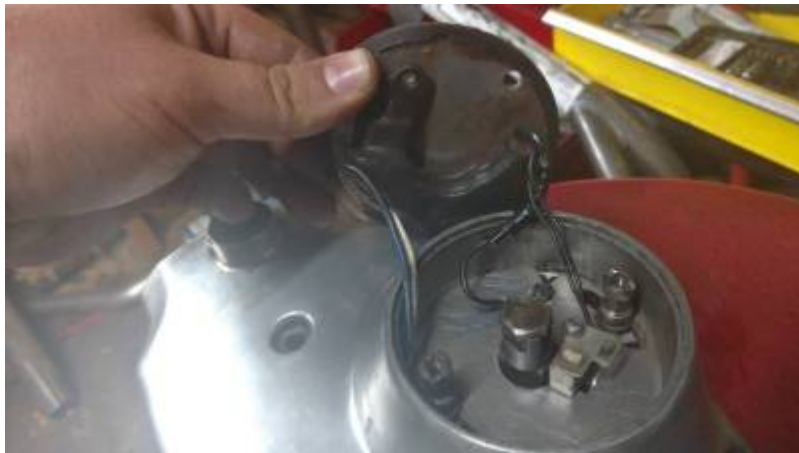
**(1979)** Upgrade to the breaker point system in which the mechanical points are replaced by a breaker-less electronic ignition on the camshaft. Timer has a rotor with one small lobe and one large lobe and a sensor that sends signal to the control module on the back of the timer inner cover. Rotor is mounted on a mechanical flywheel centrifugal advance like a point cam would be in a breaker point system. The rotor's small lobe fires the front cylinder and the large lobe fires the rear cylinder. <sup>1)</sup>1979 Ignition Module Assembly part number 32598-78 <sup>2)</sup>.

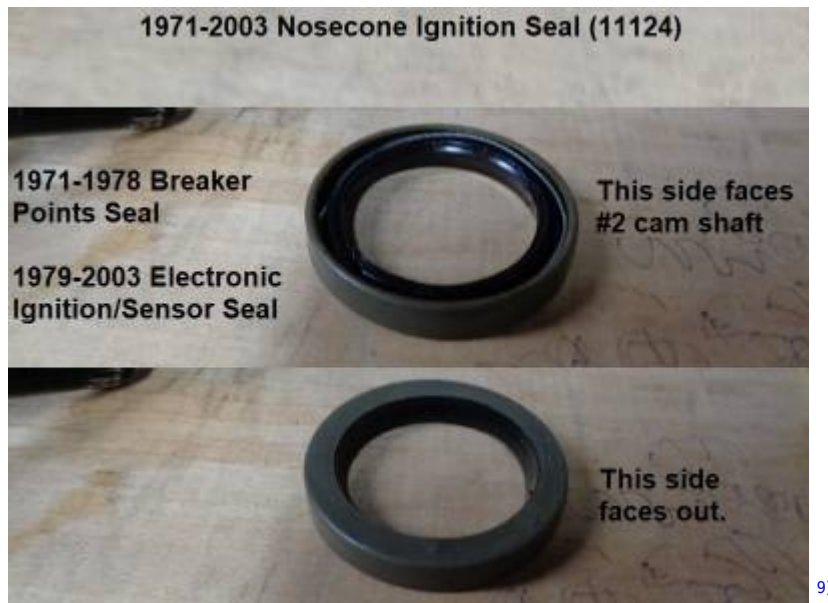
HD Seal (11124):

This is a steel shell radial shaft seal (HD# 11124) installed in the cam cover.

It surrounds and seals #2 cam when the cover is installed. Also used on 1986-2003 model Sportster cam covers.

OD 1.570" (39.878mm) ID 1.050" (26.67mm) W 0.248" (6.2992mm)
