REF: Service Procedures 11M

Accessing Transmission Gear Damage

Understanding Spur Gear Life

Understanding Spur Gear Life TRSM0913

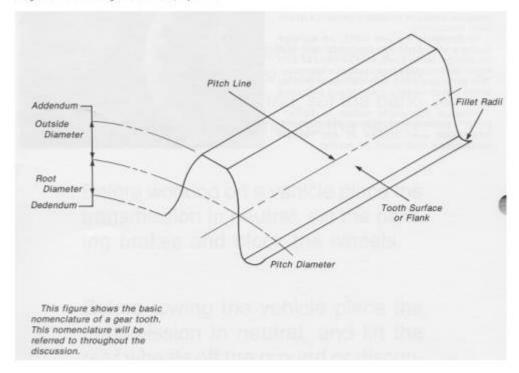
Tooth Nomenclature

To better understand the following sections of this guideline, a description of tooth nomenclature and operation, as well as tooth design and manufacturing considerations, is provided.

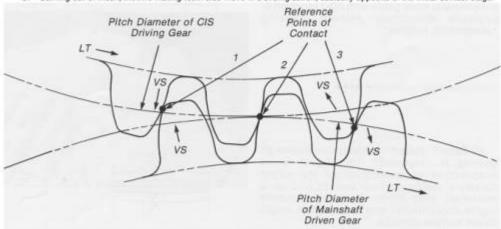
Mechanics of a Spur Gear

The teeth of two gears during operation (or mesh) pass through three stages of contact:

- Coming into mesh, initial contact occurs in the dedendum (lower) portion of one tooth (on the driving gear) and in the
 addendum (upper) portion of the mating tooth (on the driven gear). At this point of torque transfer, tooth loading (LT) is
 relatively light, since most of it is carried by the teeth in full mesh and a portion by the teeth going out of mesh. Contact
 between the two teeth moves in a sliding action as they proceed through mesh. The sliding velocity (VS) decreases until
 it is zero when the contact points reach the intersection of their common pitch lines.
- At full mesh, the two teeth meet at their common or "operating" pitch line, there is only a rolling motion, no sliding. However, this stage produces the greatest tooth loading.
- 3. Coming out of mesh, the two mating teeth also move in a sliding action, basically opposite of the initial contact stage.
