# EVO: Transmission & Final Drive

## Final Drive Trans Belt Sprocket Issues (Differences between 1991, 1995 & 2004)

<https://sportsterpedia.com/> - **Sportsterpedia**

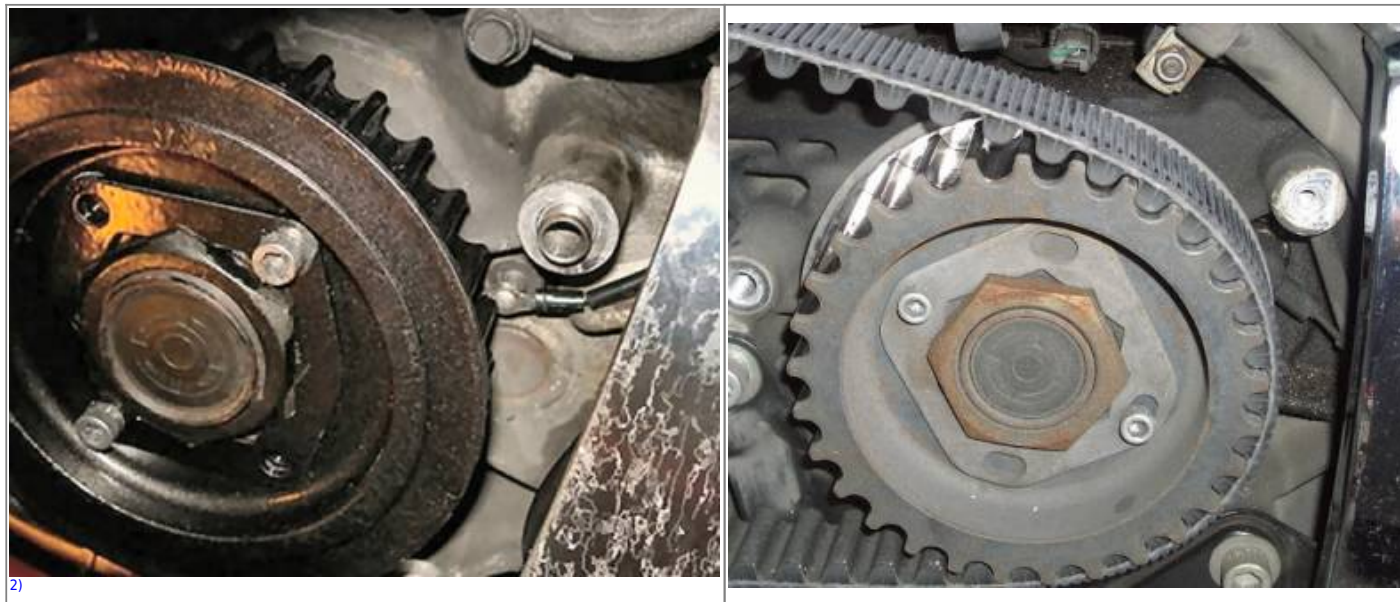
For 2004-later the sprocket flange is near the engine.

Pre-2004, on the outer flanged side, the center mounting splines are relatively flush with the flange face. But, on the engine side of the sprocket, the center mounting splines are recessed from the edge of the belt drive face. On 2004-later, the flange is on the engine side (with recessed splines there) and the mounting nut and lock plate are on the outer, flangeless, side.

On 1991-94 Sportsters, the flanged side of the sprocket is away from the engine. On the opposite side, between the case bearing seal (for the transmission Final Drive Shaft) and the recessed splines on the Trans Drive Sprocket, is a spacer to fit in that recess. The width of the splines in contact with the Final Drive Shaft is 0.500".

On the 1995-03 models, the center spline contact area of the Trans Drive Sprocket (on the Trans Drive Shaft) was widened to 0.766" and the recess spacer was reduced accordingly. The flanged side of the sprocket is still away from the engine. (As a set, the seal, spacer & sprocket from 1995 can be retrofitted back to the 1991-94 models.)

On the 2004-later models, the Trans Drive Sprocket design was reversed. The flanged side was placed toward the engine, thereby pushing the usable belt surface farther away from the engine to allow for a wider rear tire (150mm). On the flanged side, the center mounting splines are recessed .400" from the flange face.

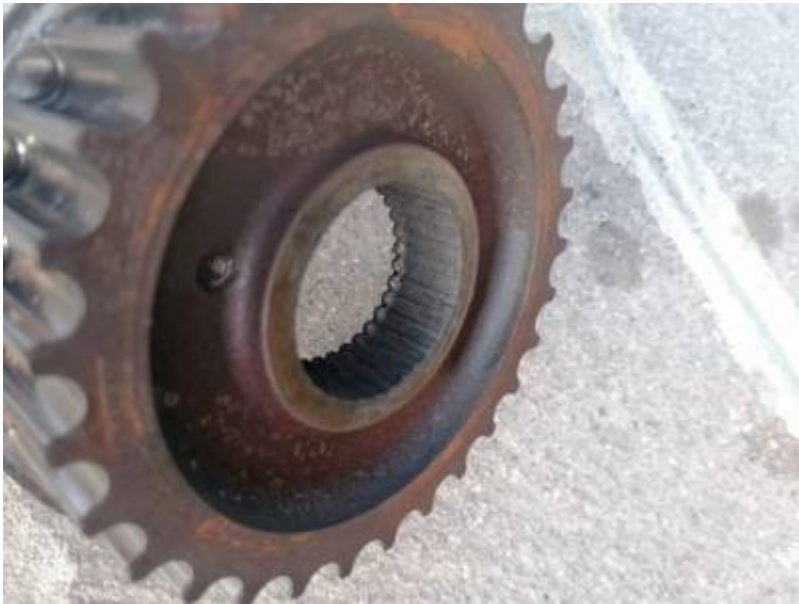
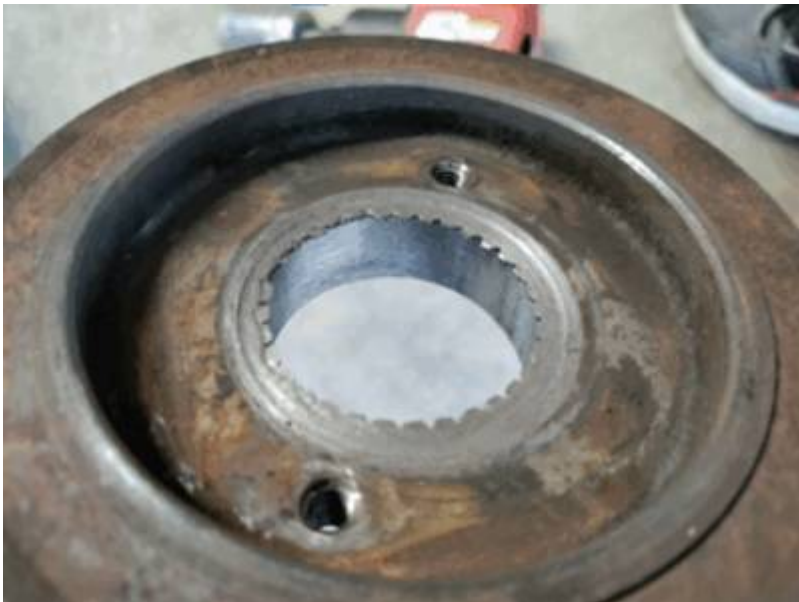
- To inspect the splines and get a visual confirmation, you'll have to remove the small screws and the big nut on the pulley.

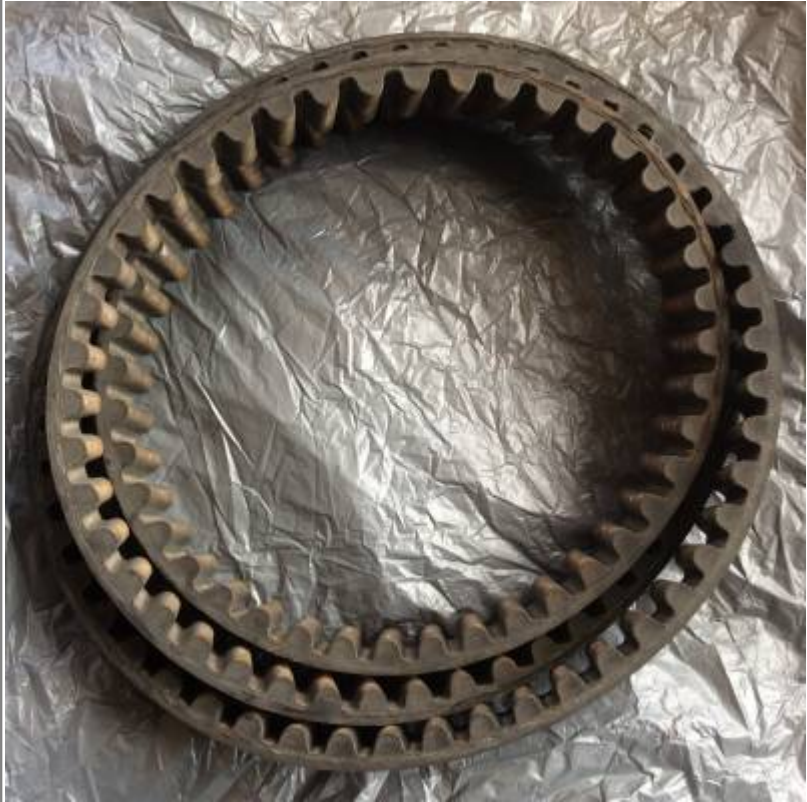
Then, carefully, do a double twist of the belt to stack it three layers high. It keeps a nice big radius (not damaging the belt) and packs well.

The suggested way to replace the belt<sup>14)</sup> is to remove the lower bolt from the shock and swing it out of the way. Loosen the axle nut and the axle adjusters so the tire can move forward.

Slip the belt up and over the belt guard, over the front sprocket, then onto the rear sprocket from behind.

Push the tire back and readjust the adjusters & tighten the axle. Then align the shock and replace the lower bolt.
