# IH: Carburetor, Intake Manifold & Exhaust - Sub-01G

## Tillotson Carb Functions, Adjustments, Tuning

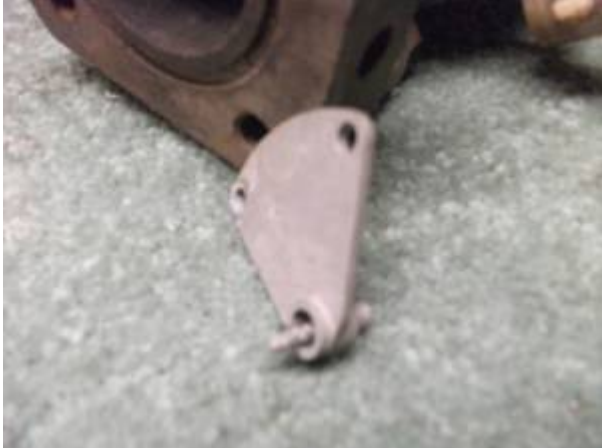
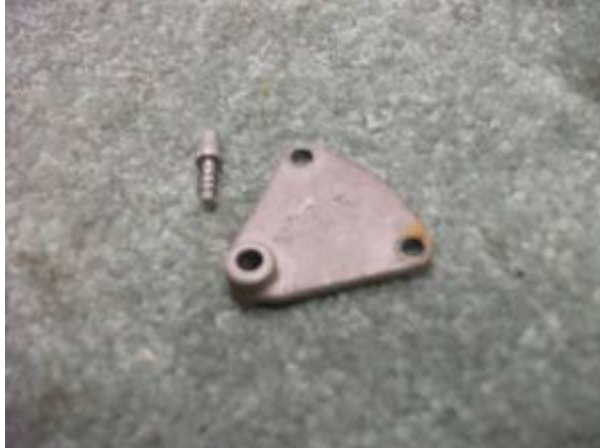
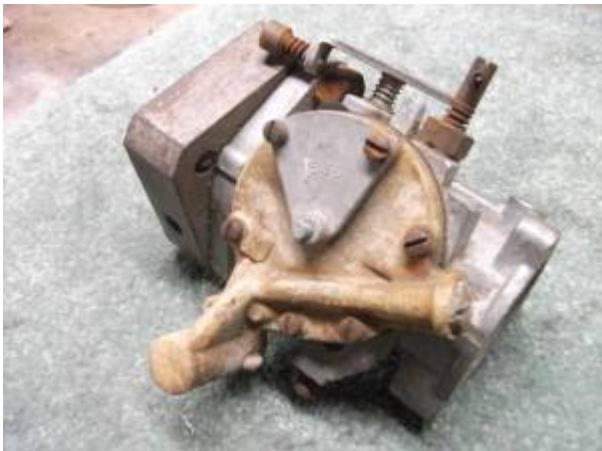
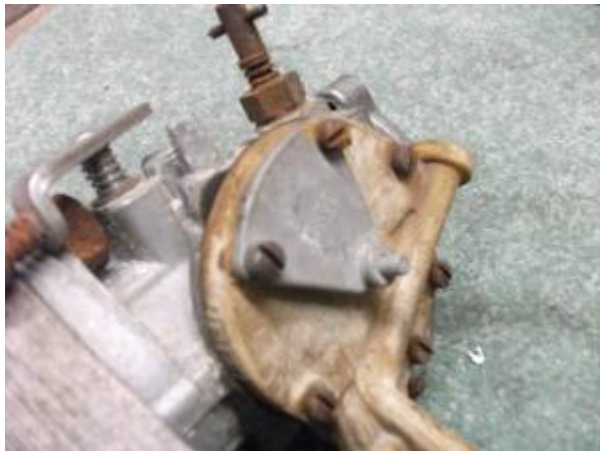
This was made by S&D installed on a HD2D model.

There is an old trick of using a paperclip to depress the diaphragm through a small hole in the diaphragm cover on the bottom of the carb.

Using the paperclip method can be cumbersome with the fuel line, original air cleaner, circuit breaker and tach cable in the way.

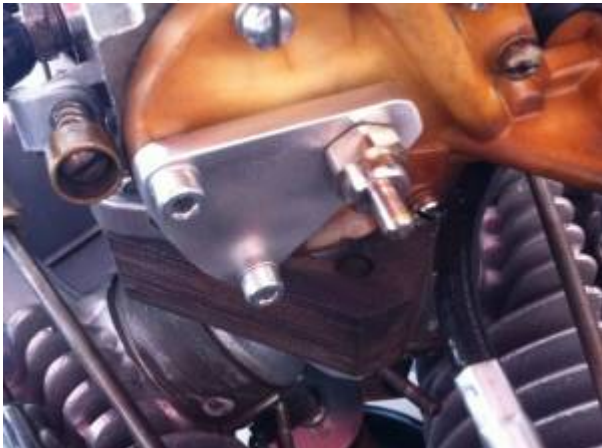
7)

This is an original Tillotson on a 1969 XLH.

Since vintage ticklers are now pretty much unobtainable, the one below was homemade.

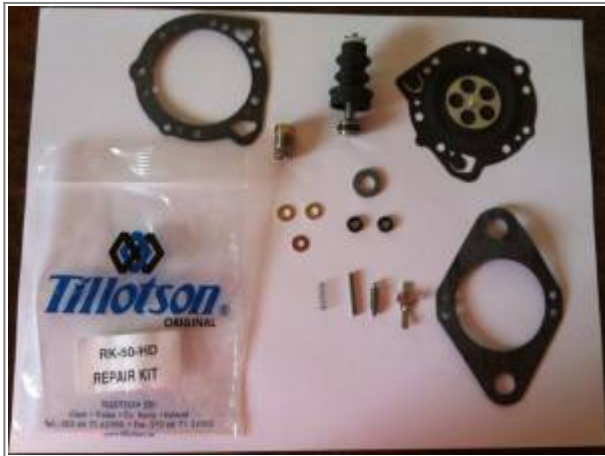
Tillotson Carburetor repair/ refresh kit<sup>19)</sup>
