IH: Engine Control - Sub-03A

1968 Kicker Cover Roll Pin Repair

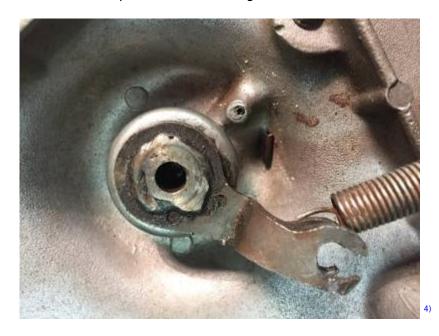
The little roll pin sticking out of the inside of the kicker cover acts as a stop pin. The release should rest on the pin when the clutch lever is fully extended and the adjustment of the release rod is slack. ¹⁾ Sometimes they will snap off. This could be due to it being a pretty wimpy size pin, and possibly bad clutch adjustment followed by abuse. ²⁾

Up to '67, the hole was drilled all the way through where you could drive the old pin out from below. However, the sprocket cover changed in '68. 3)

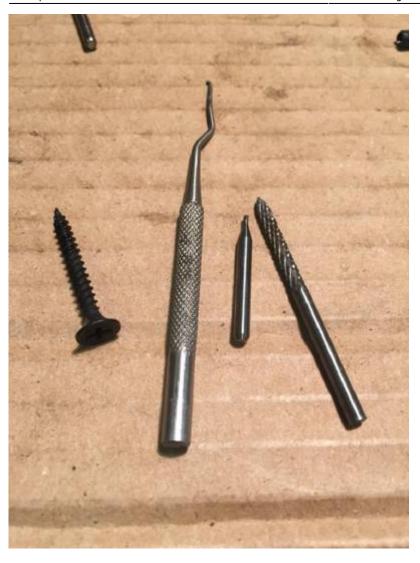
- Most of the advice on this is probably good for larger size pins and did not work for this situation including: 5)
 - ∘ Pick = no good
 - ∘ Heat / pick = no good, it's jammed.
 - Pack with grease and use pressure to push it out = Too mangled, too small.
 - Easy out = if I had one that small, I think it would just expand the pin.
 - Hardened drywall screw to yank on = screw too big / pin too hard for softer screws.
 - Try annealing pin to allow drilling = maybe a jeweler's torch setup would be good for this.
- Other trial methods might include:
 - A long drill bit to go through the center of the roll pin and out the bottom.
 - A left handed drill bit ⁷⁾

- On further attempts, I succeeded in blocking up the hole with a welding rod, which was supposed to have fused itself to the inside of the pin at low amperage, allowing me to yank it out. Instead it broke off at the top of the pin. 8)
 - I managed to drill out the welding rod, snapping a succession of cheap solid carbide drill bits used in PCB manufacture.
 - A step before trying to spark erode the little sh!t out of there (machine paid for itself, removing broken easy outs, I hear) when I tried a carbide burr. Snapped that too, but it got deep enough to hog the old pin out before that happened, and I managed to pick the broken bits out.

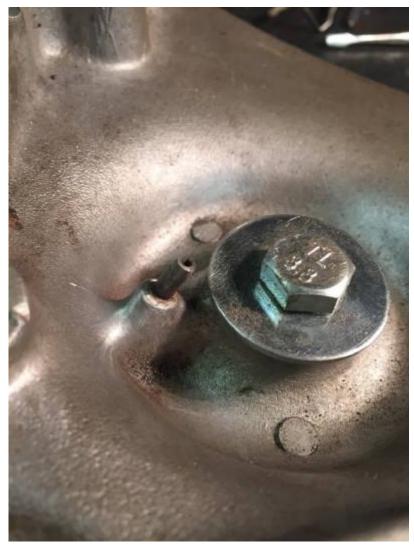
New 1/8" roll pin fitted. If this bigger size makes any difference, you can always relieve the arm a touch. ⁹⁾ but the larger pin would help with shearing. ¹⁰⁾

Now I can adjust the clutch!!! 11)
