# IH: Wheels, Brakes & Tires - Sub-02A

## Rear Drum Fitting Issues with a Rigid Frame

(How the drum indexes to the hub)

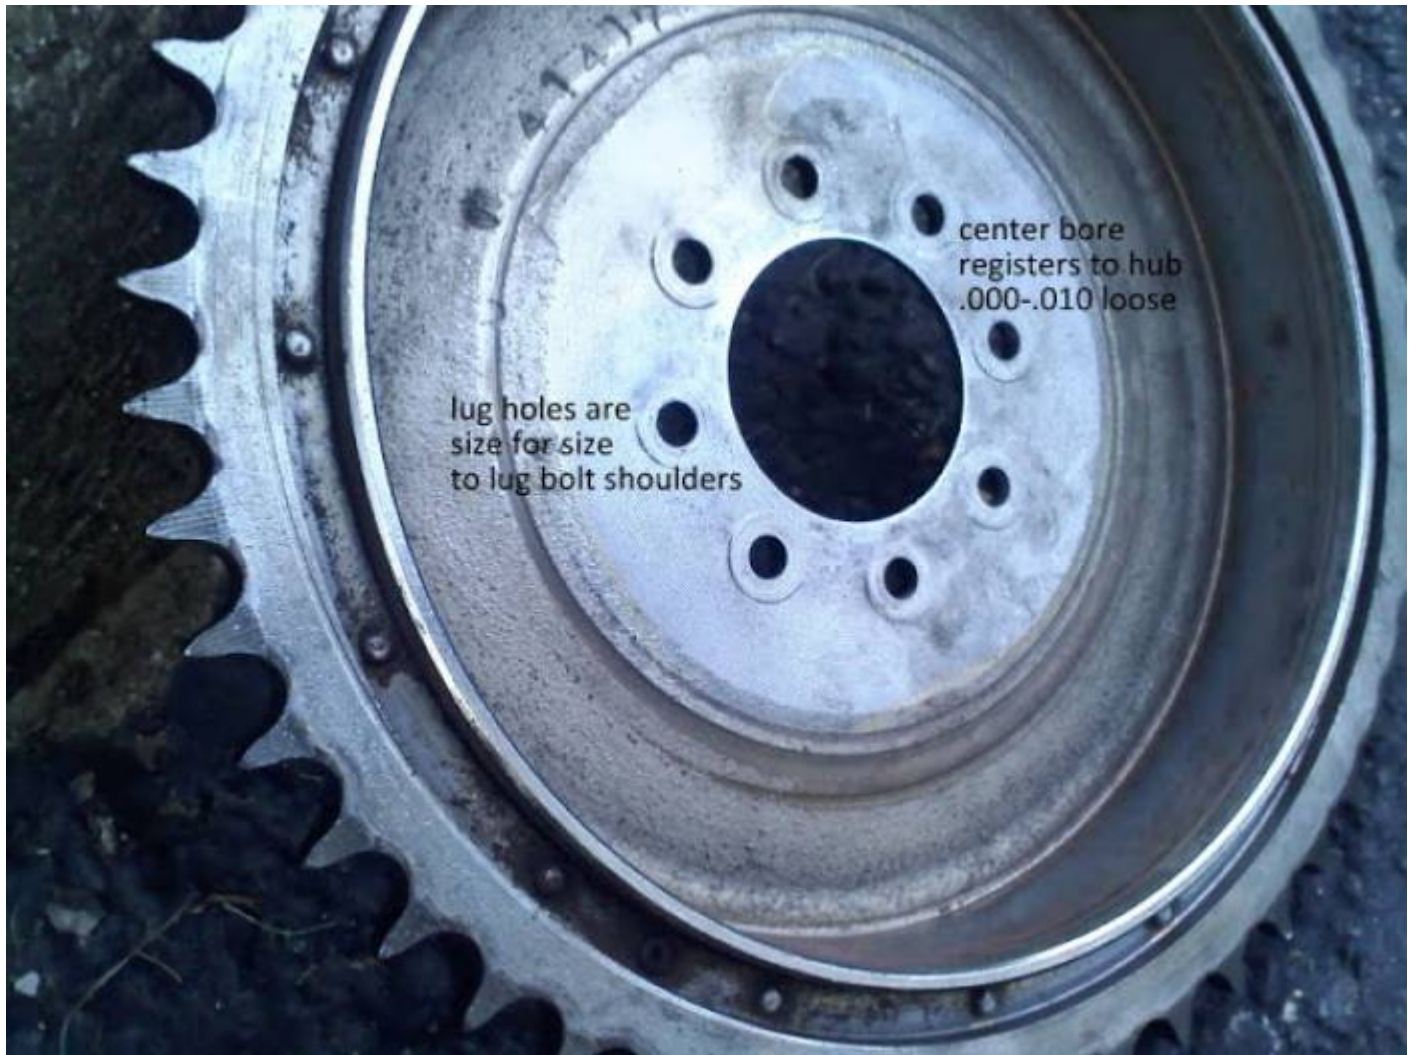
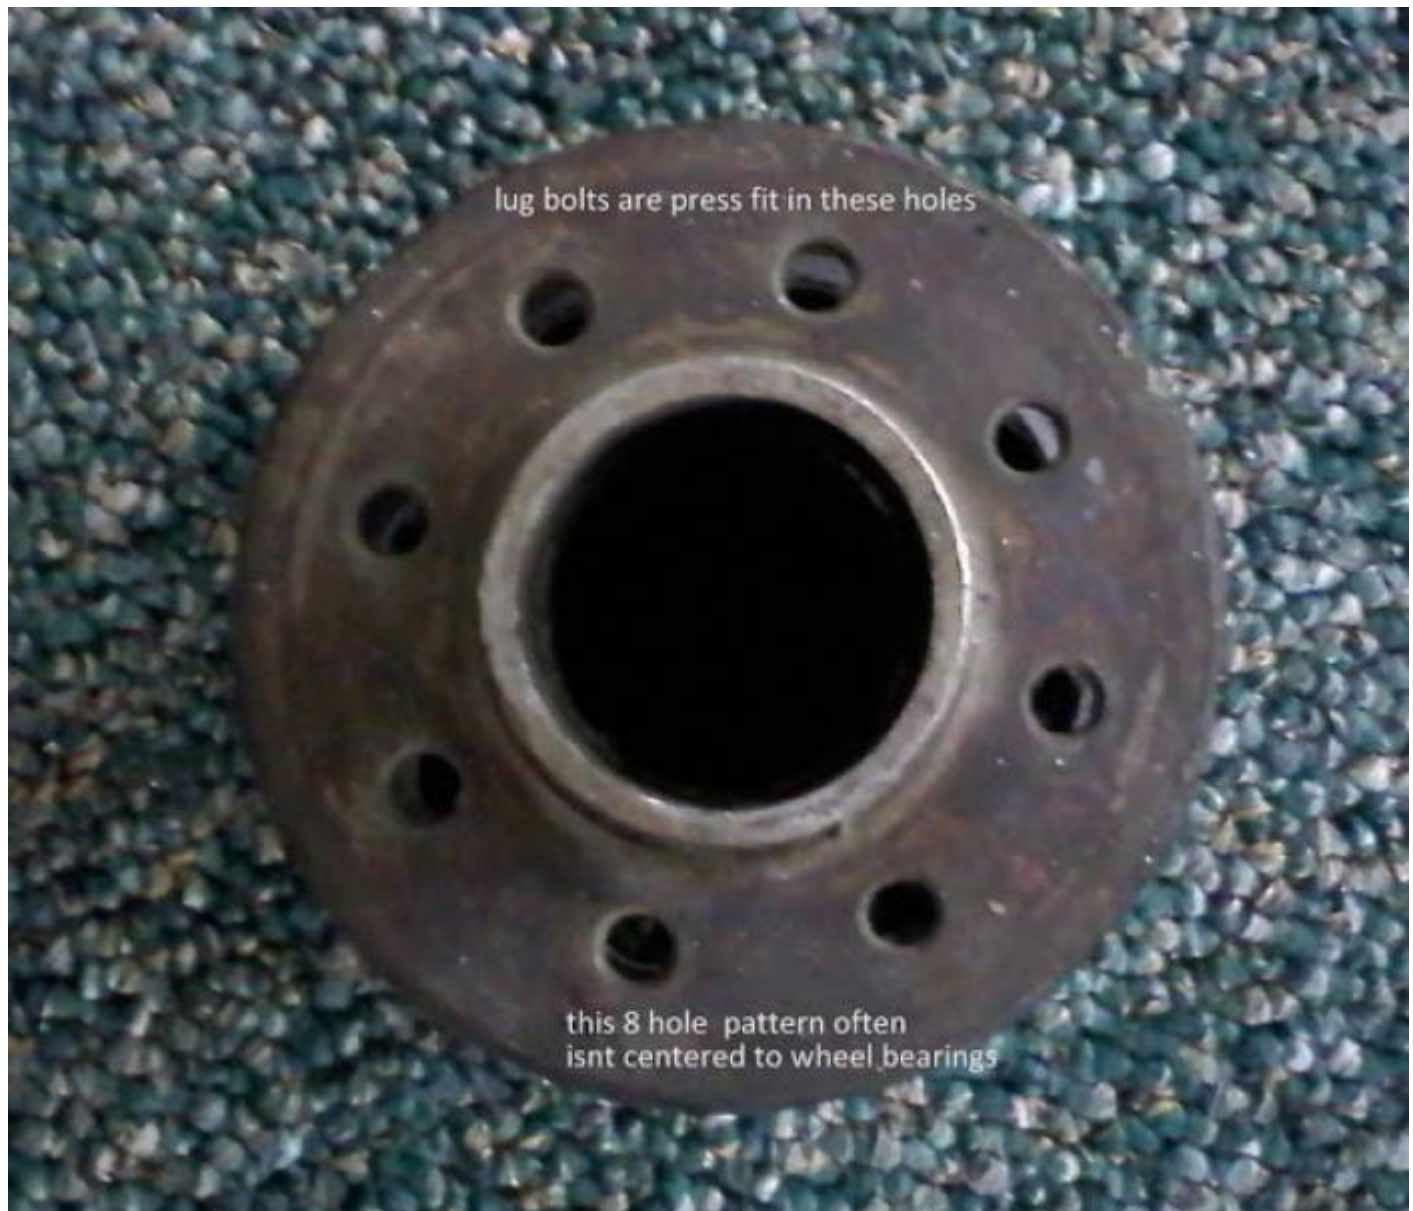
- When the drum goes on the hub, it would make sense that the center bore of the drum registers on the hub neck and sets the drum true to the hub.
- Instead the tight fit of the lug bolts (in both the hub and the drum) pin the drum to the hub and sets location.

- It's the lug hole circle that does the locating.
- On the hubs, I have found this (hub hole circle) to be out of location many times.
- The drums usually aren't too bad.
- So, to determine if you have this problem and which part is faulty:
  1. Assemble the drum to the hub with all lugs in and tight.
  2. Put the axle in a vise and slip the wheel on.
  3. Put a dial indicator on drum surf and spin it.
  4. Mark the hub and the drum at the 'high spot'.
  5. Remove the drum and index it at 180° on the hub.
    - If the high spot stays with drum, the drum is the problem.
    - If the high spot stays with hub, the hub is the problem (I see this more often than drum problem).
- To rectify this, you need to decide what parts are the culprit and then figure where to go from there. It's easier said than done and messing with the lug holes and not losing the lug pin fit is a

- Unlace the wheel. Try all 8 positions to find least run-out at the sprocket mounting diameter of the drum. Mark the drum and the hub so they can be assembled in the same position later. Without the drum mounted on the hub, chuck hub true-ness on the bearing bores in a lathe. Skim the face of the hub flange for flat & true at the drum mounting surface.

- Install the drum and re-chuck the hub and drum as before. Skim friction surface true. If needed, open up the minor diameter of the 49T and screw it to drum. True the sprocket pitch diameter for run-out and tighten the screws. Drill the drum and sprocket for .187" rivets.
