TT321 – July 23, 2007

### **Twin Cam Crankcase O-Ring Eliminated**

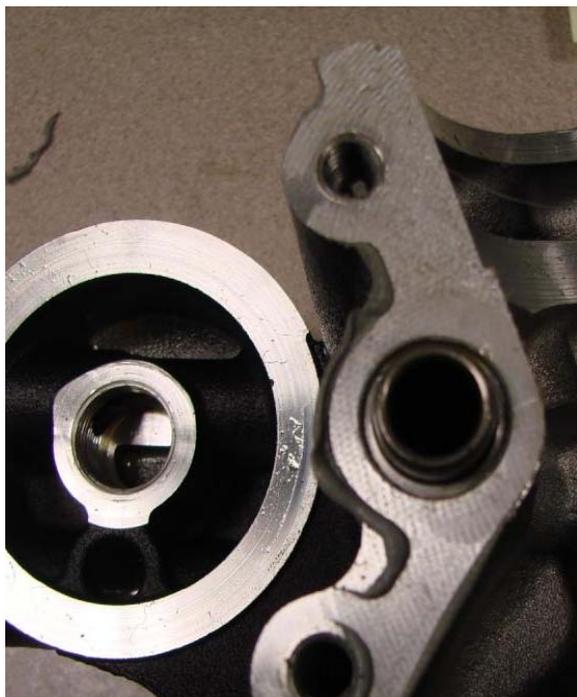
**Early with O-Ring**

As a late Model 2007 running change, (5-25-2007) the O-ring part # 26432-76A has been eliminated from the dowel used between the crankcase halves on Twin Cam engines and replacement crankcases.

The part # is still available for use on early crankcases, but should not be used on engines without the machined groove for the O-ring.

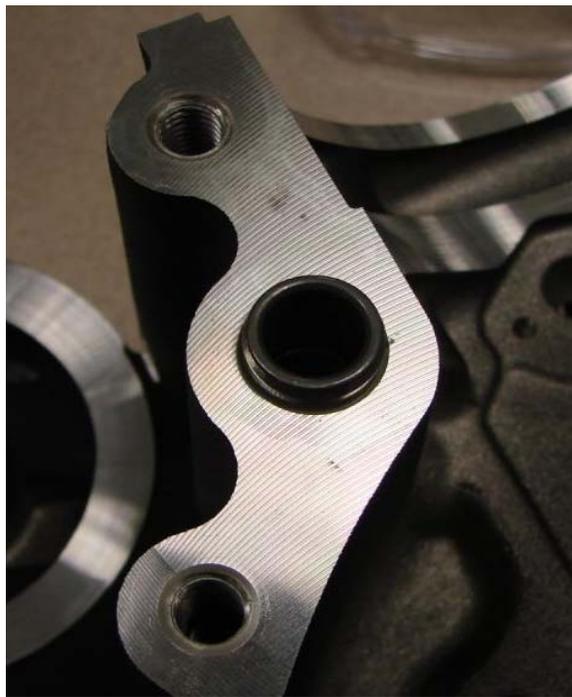
**Late without O-Ring**

The change allows more consistency in application of sealant to this area.
