# TT462: SHIPPING KEYS CABLE STRAPS

APPLIES TO	SYMPTOMS
All vehicle platforms	• PDI (Predelivery Inspection)

The assembly plants are implementing a **new** cable strap.

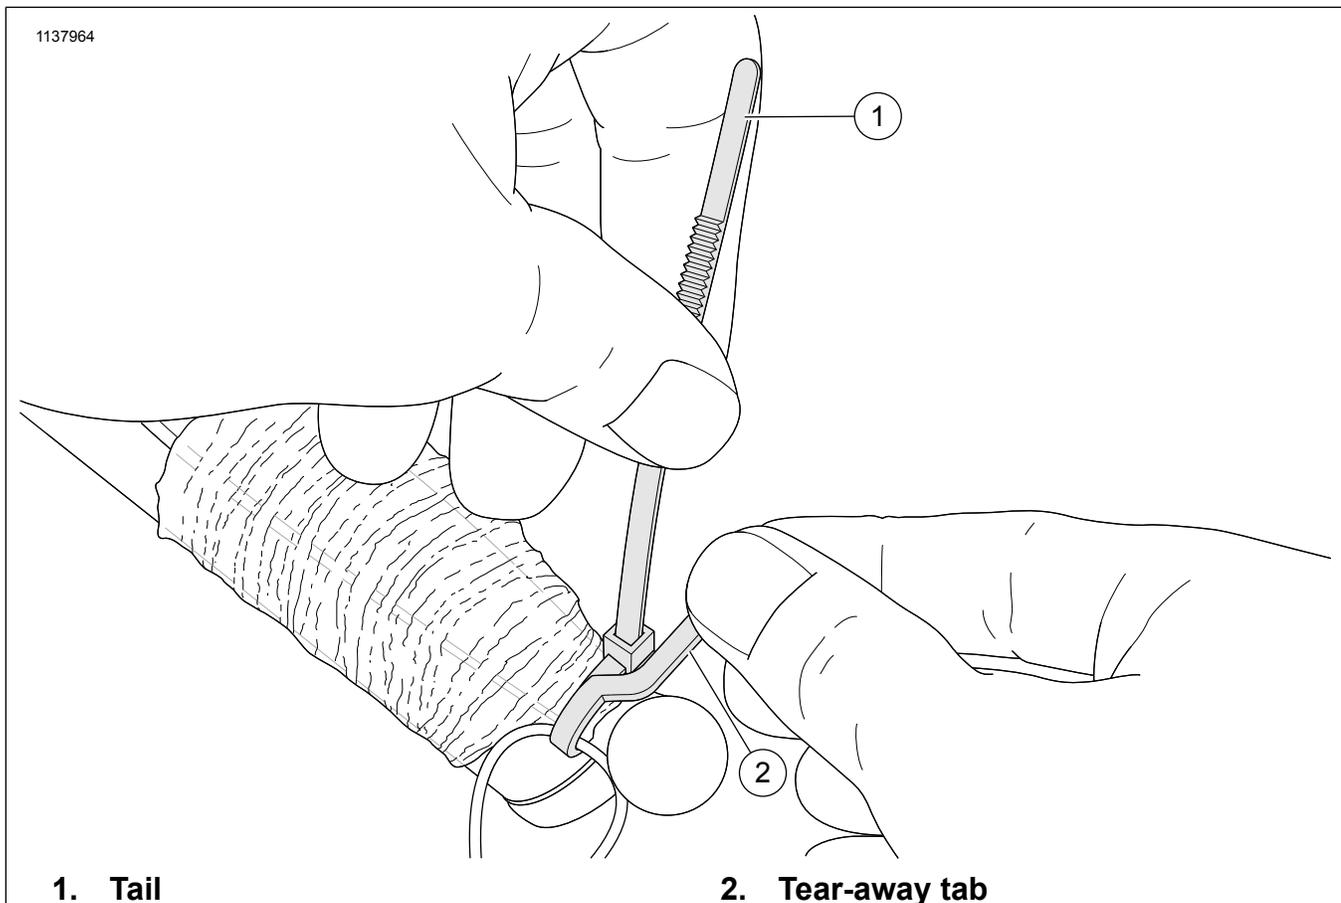
**Figure 1. Tear-Away Cable Strap**

Damage has occurred on some hand grips or brake levers when using side cutters to cut the cable strap that holds the keys in place.

1. See Figure 1. Remove tear-away cable strap.
  - a. Grasp tail (1) of cable strap with one hand.
  - b. Grasp tear-away tab (2) with other hand.

- c. Pull tab to release. Refer to Video.

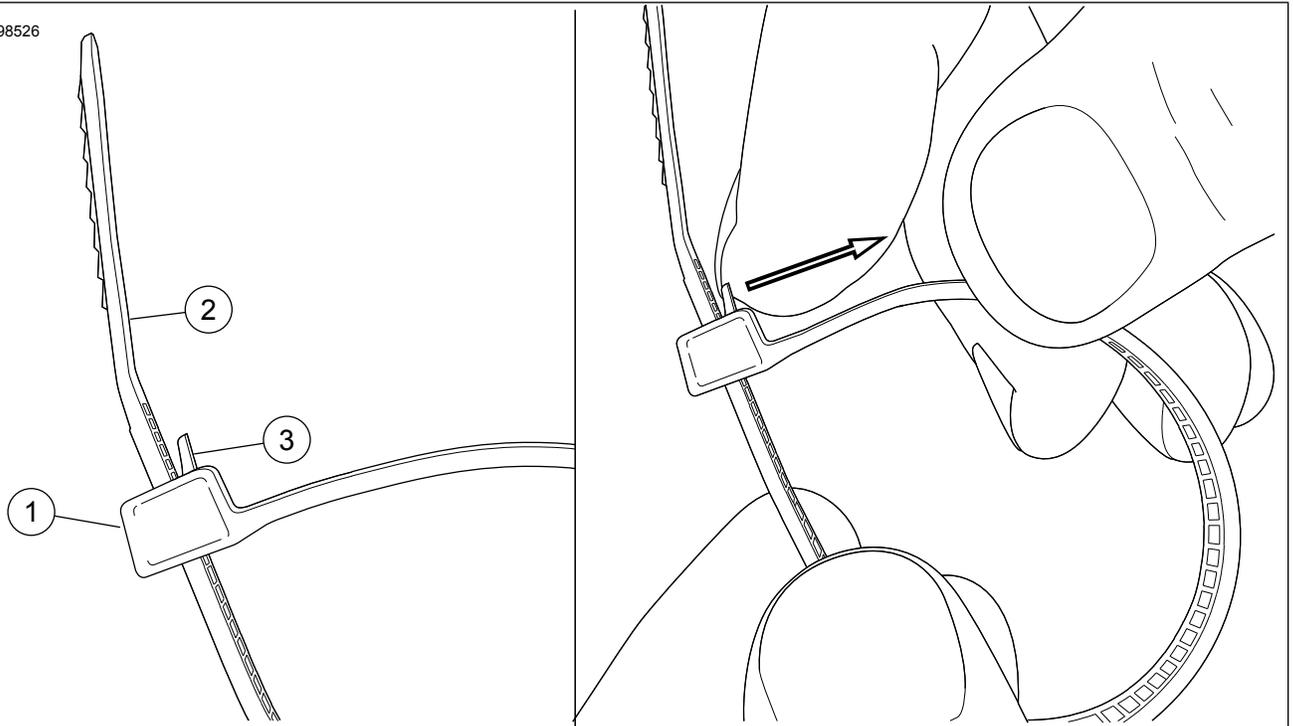
**Figure 2. Quick Release Cable Strap**

- 1. Head
- 2. Tip

- 3. Release tab

1. See Figure 2. Remove quick release cable strap.
  - a. Put finger nail between the tip (2) and the release tab (3) in the head (1).
  - b. Pull release tab away from the tip.
  - c. Remove tip from head.
  - d. Remove cable strap from vehicle. Refer to Video.
